Doline Collapse – Wellington Hole, Waitomo, NZ

Stephen Swabey, Swabey Consulting 4 Allans Beach Road, Portobello, Dunedin (03) 478 0909, stephen@peninsula.co.nz

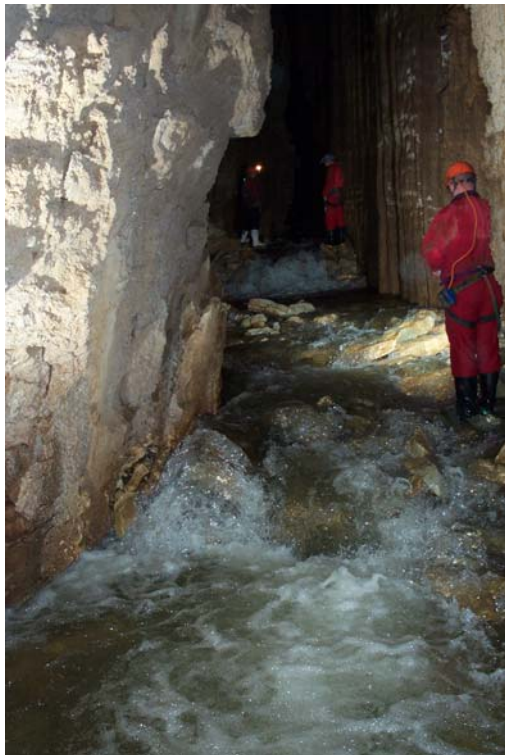
During the visit it was noticed that the vertical walls on the northwest and southeast sides of the upper half of the doline had not been eroded, but the wall on the northeast (towards Troopers Road) had been smoothed off (top of Figure 3), suggesting large material had passed down the slope. At the bottom of the vertical shaft a pile of limestone boulders and road gravels was found in the stream. This pile extended approximately 60m downstream from the shaft (Figure 2), but not upstream.

Figure 2: Limestone blocks in the cave, looking upstream to entrance shaft. Person in white gumboots is standing directly below the entrance shaft.

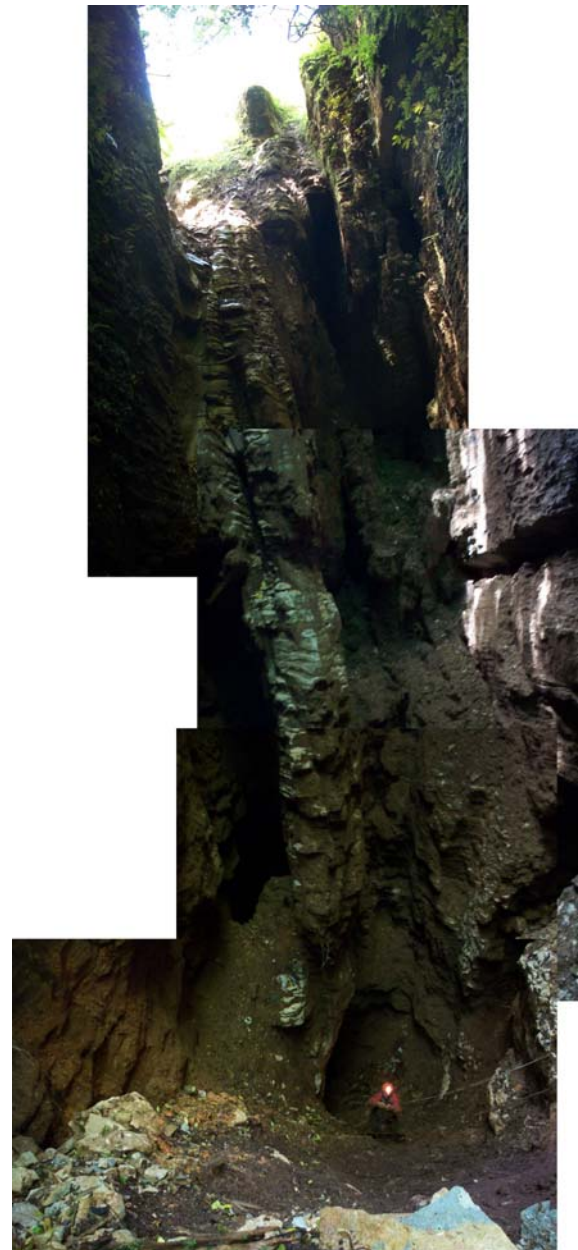
Figure 3: Composite photograph of the Wellington Hole entrance shaft.

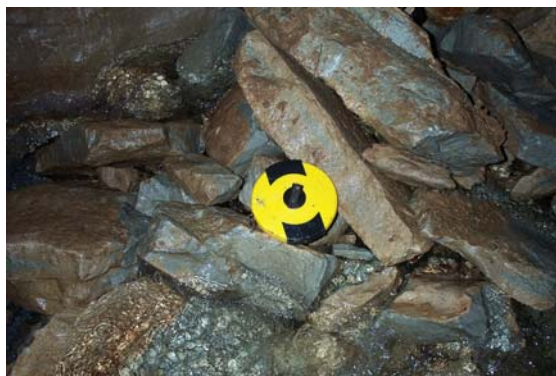
The maximum diameter of the limestone boulders at the bottom of the shaft was approximately 1.2m (see Figure 4). The limestone showed three types of weathering condition:

Figure 4: Limestone blocks in the stream at the entrance shaft. Tape diameter, 0.2 m.

The limestone material deposited in the cave stream is similar in size distribution, shape and weathering surfaces to the limestone blocks situated outside the cave. (Figures 6 and 7). The blocks in the cave clearly show the freshly weathered surfaces evident on the material at the surface (Figure 4). Freshly weathered surfaces such as this are not found on limestone blocks that have been in cave streams for more than a few months.

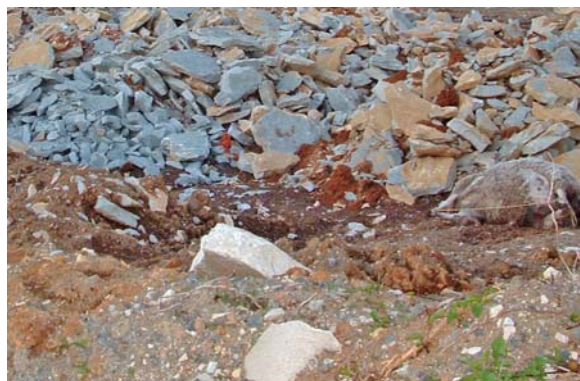
Figure 5: Limestone blocks outside the cave. Dead sheep is 1.2m long.

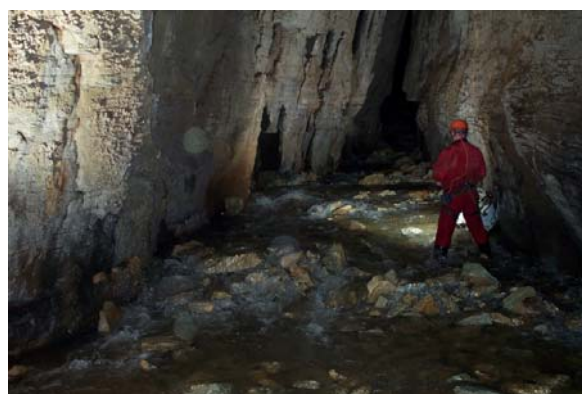
Figure 6: Limestone blocks inside the cave. Figure is 1.7m high.

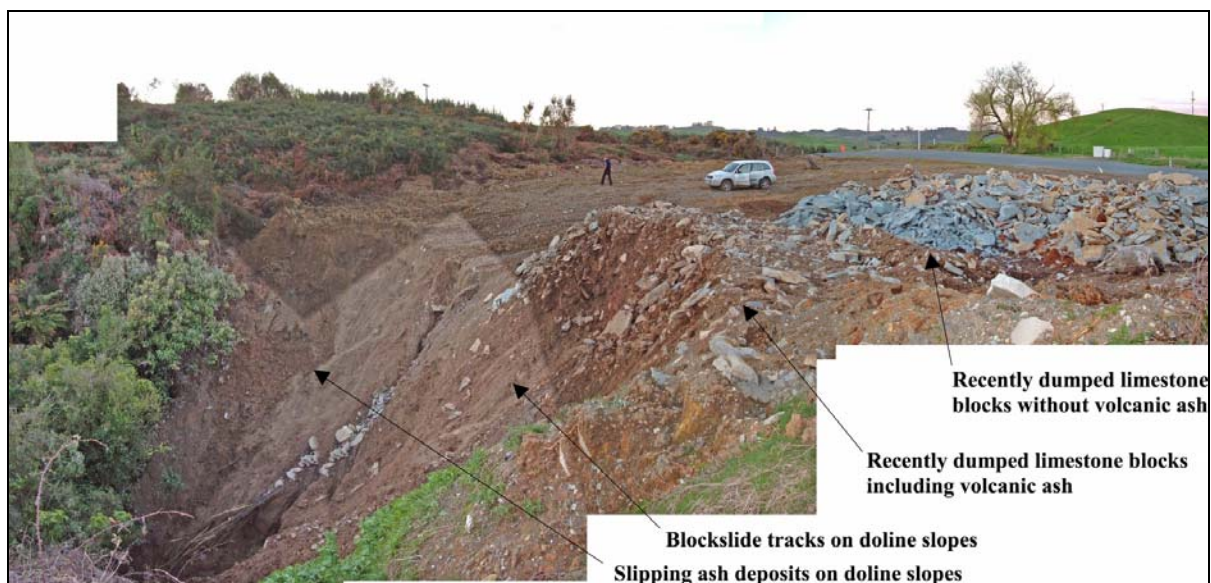
The process of material deposition in the cave was by fall down the doline from the lip of the doline. A composite photograph supplied by Roger MacCulloch (Environment Waikato) shows this very clearly (Figure 5). In the photograph two different piles of limestone blocks are visible in the right foreground. The pile on the extreme right of the photograph does not include volcanic ash and was probably derived from a limestone face, given the mix of weathered and unweathered limestone. The pile in the centre of the photograph includes some volcanic ash and was probably bulldozed into that position. Clearly visible on the slopes of the doline below the left-hand pile are tracks where rocks have slid down the doline. Also visible on the far side of the doline are minor slip features in the ash, indicating that the ash is close to its angle of repose. The gradient of the

The angle of the batter in the rock pile in the left of the photograph is higher than the slope of the doline below, indicating that the pile has failed into the doline recently. There are no major slump features apparent on the lip of the doline, suggesting the rock material has been dumped into the doline, rather than slumping from the surface.

Figure 7: Composite photograph of the entrance to Wellington Hole.
