Recent developments at Cotter Cave, ACT

Text and photos by John Brush Canberra Speleological Society Inc

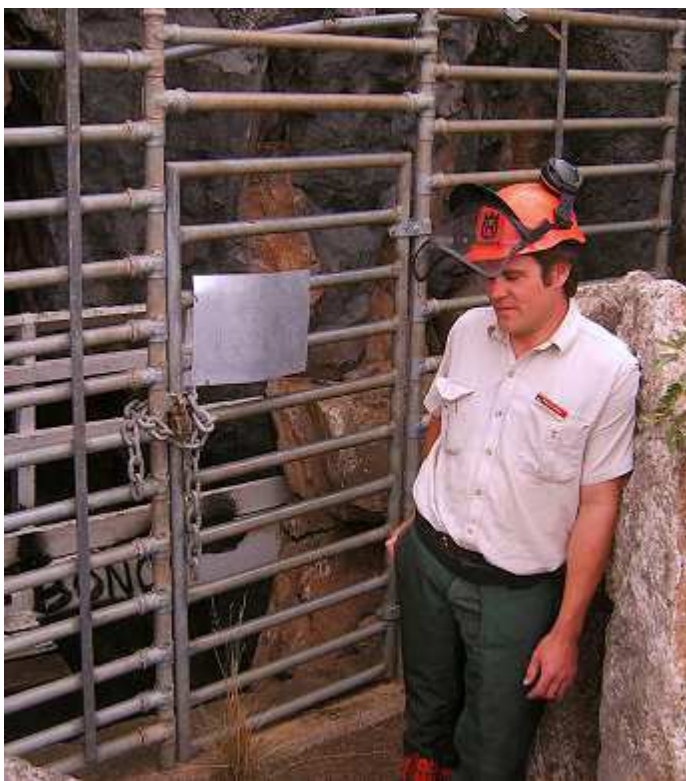
The entrance to Cotter Cave as it was in 2005. The steel gating structure dates from the 1970s

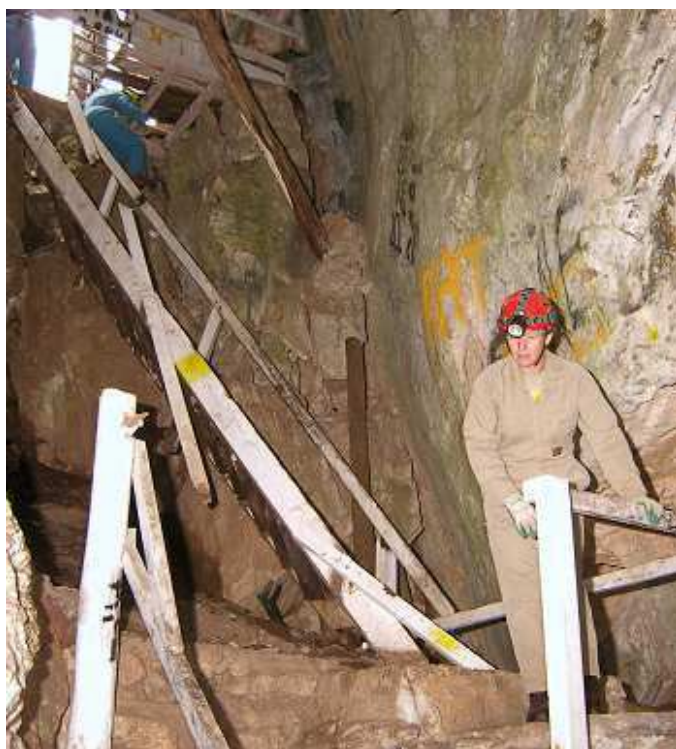
The remains of the fire-damaged entry stairs just prior to their removal in February 2005

In February 2005, CSS worked with ACT Parks to remove the remains of the wooden stairs that had been damaged by the 2003 bushfire.

At that time, ACT Parks and CSS agreed that complete removal of the stairs in conjunction with installation of a new entrance barrier would enhance visitor safety and reduce unauthorised access. Ideas for a new structure were subsequently exchanged. However, the communication lines later broke down as key Parks staff moved on and CSS focussed on other karst areas.

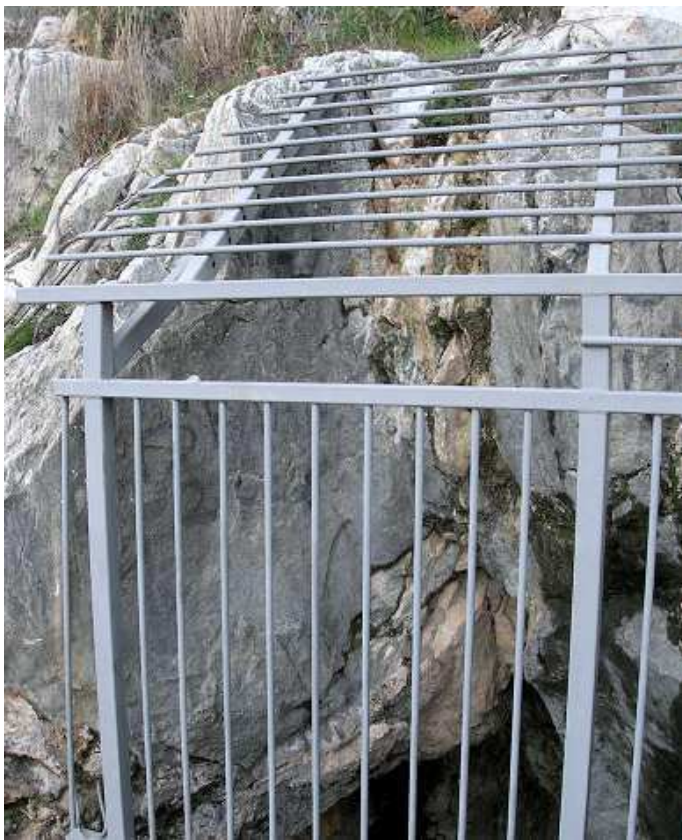
On CSS's next visit to the cave in mid-2007, members were appalled by the new structure that had been constructed over the entrance. It was highly visible from afar and appeared to be neither very vandal-resistant nor 'bat-friendly'. Although the barrier had a strong frame, the bulk of the structure was made from thin (25 mm diameter) vertical steel rods. Vertical bars can hinder entry and egress of bats and the only horizontal gap was near the top of the new structure – a gap which was also not ideal for the bats.

The new (2007) entrance was not 'bat-friendly' or vandalism resistant. Subsequent modifications were of limited success in overcoming these basic design flaws.

It soon became apparent the new structure was not very resistant to vandalism and, with the additional concerns about public safety and bat access, CSS called for the structure to be modified or (preferably) replaced. Over the next decade, several modifications were made but these were of limited success in overcoming the original design flaws.

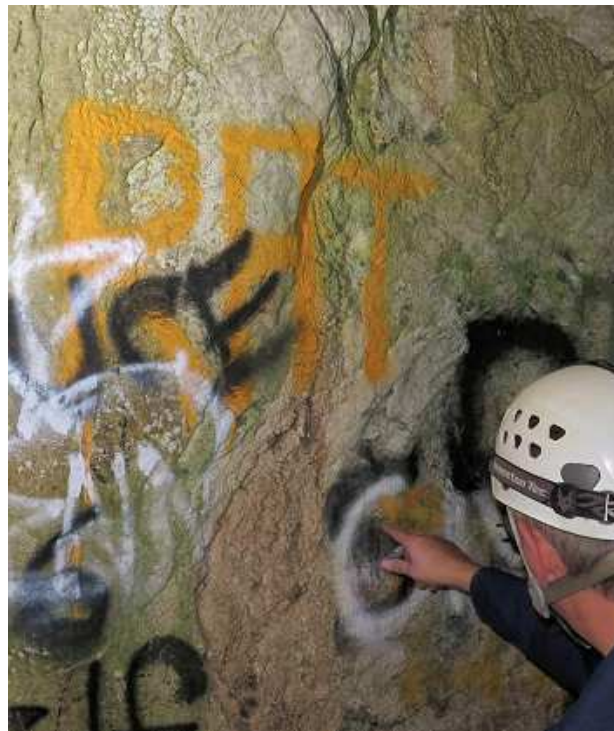
As the integrity of the entrance barrier was often compromised by vandalism, graffiti attacks inside the cave were common and, of course, the effects were cumulative. In addition, empty drink bottles and cans were frequently dropped into the cave. On occasion, the evidence left behind suggests there were campfires,

Spray-painted graffiti occurs throughout the cave obliterating, in places, pencilled inscriptions from the first half of the 20th Century

CSS made many trips to remove rubbish from the cave. It also conducted graffiti-cleaning trials in 2016 and 2017 but members decided it would be futile to initiate a major cleaning project until a more secure entrance barrier had been installed.

For CSS, the new gate represents a significant milestone in the lengthy campaign to improve management of the cave. If the new structure proves to be more resistant to illegal entry, it will open the way for CSS to initiate a major graffiti removal project in partnership with ACT Parks.

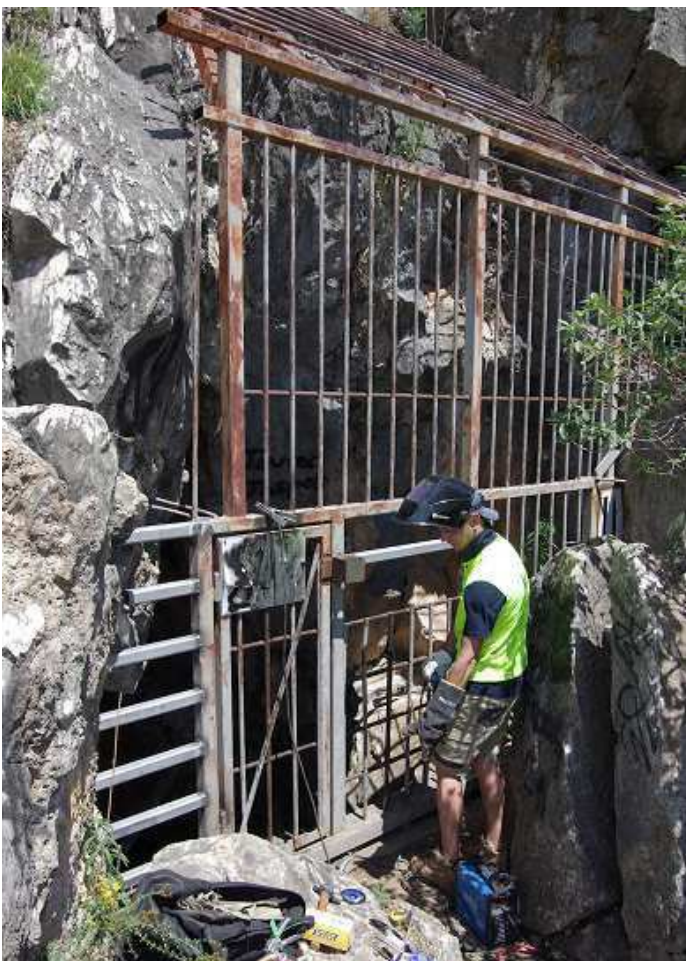
Above: The first day of work in January 2019 to replace vertical rods with horizontal square-section tube

The contractor commenced on-site work on 21 January 2019. ACT Parks decided to keep the framework of the existing structure so that the round bars would be simply cut off and replaced with larger square-section tube, which included features to increase resistance to damage. The round bars were replaced on a panel-by-panel basis so that the cave was not left unprotected overnight. Staff of ACT Parks closely supervised the work and were equipped to deal with any stray sparks resulting from the cutting and welding work.

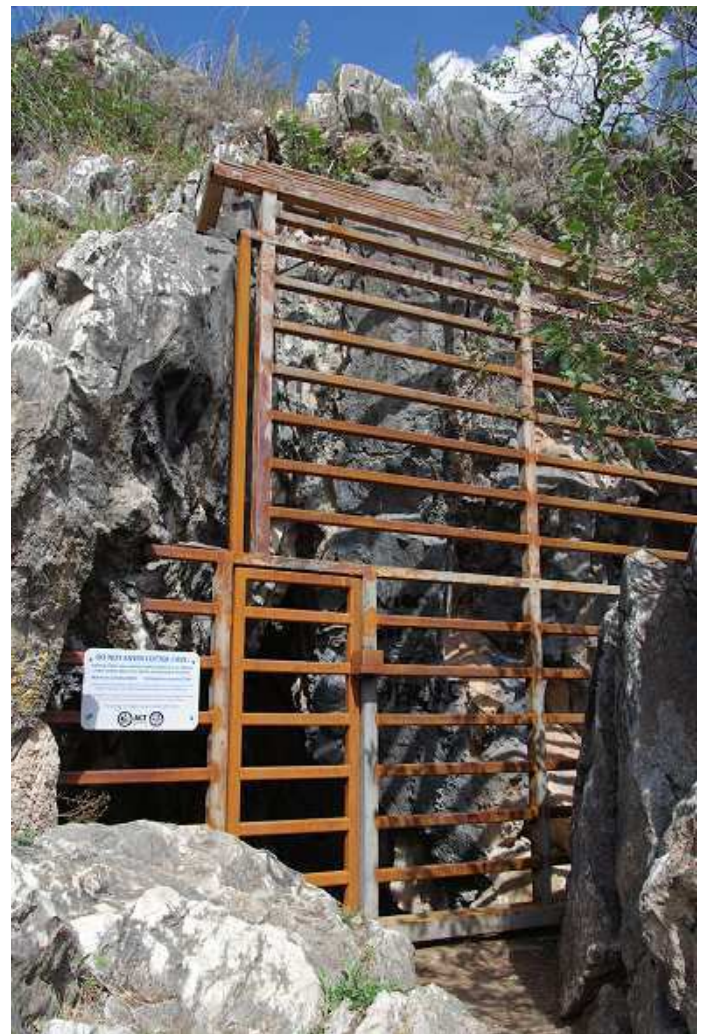
Below: The new entrance barrier at Cotter Cave (March 2019)

Fabrication was substantially completed by late February and at the time of writing (mid-March), all that remained was to add some metal guards better to protect critical parts of the gate and the locking mechanism.
