“Around the show caves”

Te Anau Glowworm Caves, New Zealand

Neil Collison

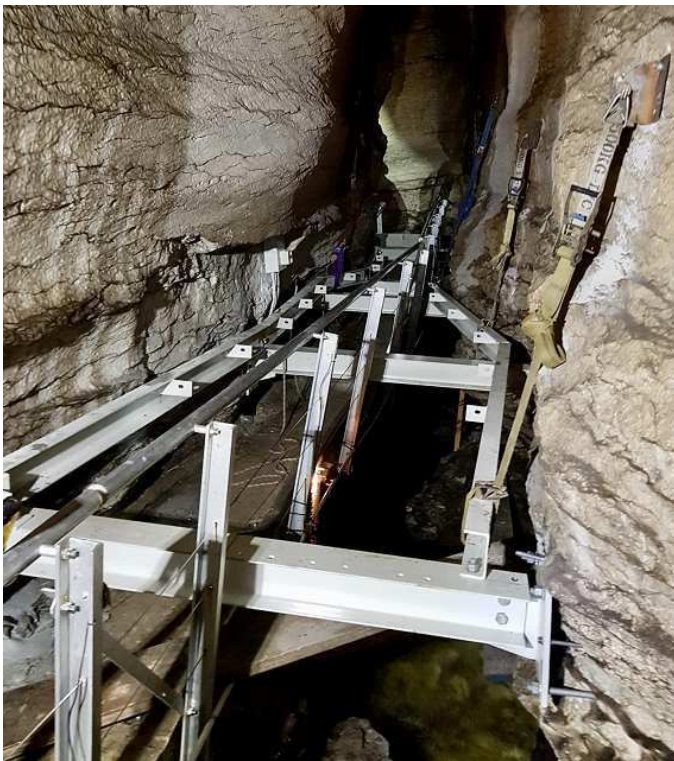
Above: Fitting the frame

The new walkway has been prefabricated using measurements that were obtained from 3D-scanning the section - with reference to the contour of the walls at the new walkway level. The parts are all pre-drilled, pre-cut, pre-painted and have fitted better than anyone could have hoped for. Stairs have replaced inclined ramps in two locations.

Despite the scale of the job, the cave has remained open throughout the works, with engineers positioning the new sections - to check for fit; slotting them in between the old handrails and slightly above the level of the original walkway - outside the tour timetable.

Once the mounting plates were bolted to the walls, the cross-members were removed until time for final positioning. A team would follow the engineers to grout behind the plates. In places, the new walkway surface spans the cave's passage from wall-to-wall. A new lighting loom is also to be installed as part of the present works, with an upgrade to slightly newer technology. New data cabling will also enable improved data collection and communication to the surface.
