MOLE CREEK SINKHOLE CLEAN-UP

– Rolan Eberhard

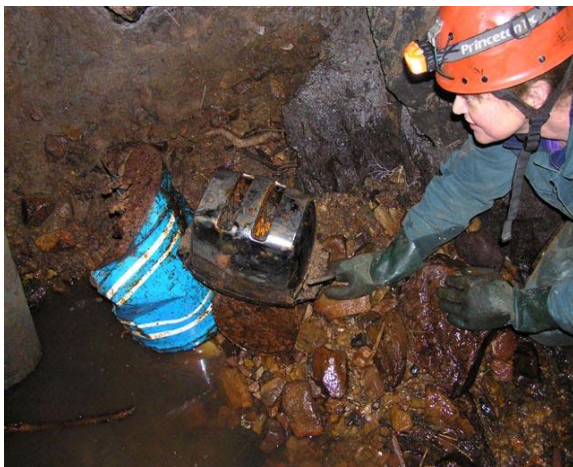
Cathie Plowman retrieving a toaster (one of two) dumped in Harrys Creek Cave.
Photo: David Butler.

In 2008 Launceston-based cavers bagged up 18 sacks of rubbish that had been dumped in Harrys Creek Cave, a streamsink on State forest west of Mole Creek township. The nasty mess included seven 20 litre fuel drums, the rusted state of which made it difficult to determine if they had contained anything hazardous at the time they were dumped

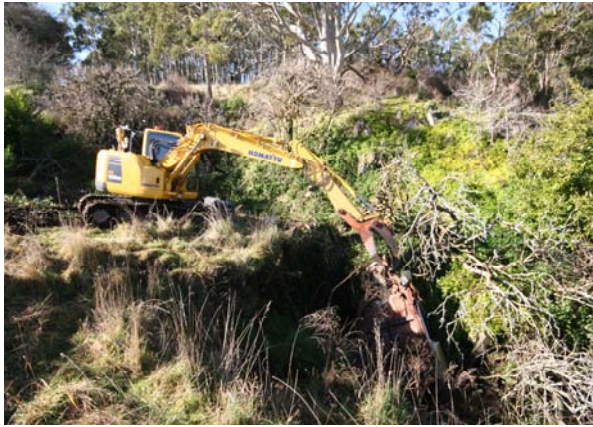
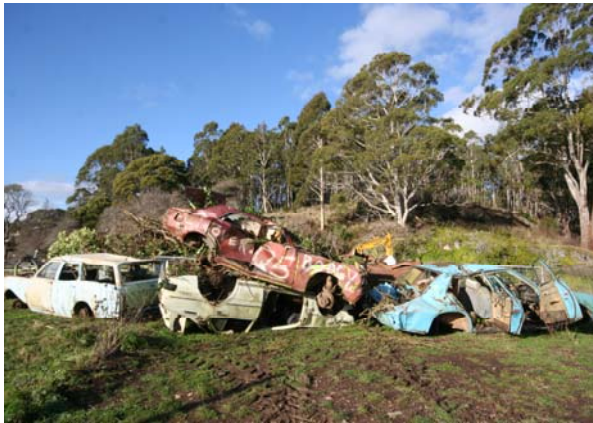
At Elderberry Cave. Above – Working to remove refuse. Below – Cars retrieved...

Technically, the most challenging site addressed in the sinkhole clean-up program is an active streamsink known as Elderberry Cave, also located on recently reserved land. This streamsink is the principal source of water in nearby White Rabbit Cave system. Several car bodies plus much domestic and agricultural rubbish had been dumped directly into the streamsink, which had been partly dozed in and was largely obscured by weeds and junk.

The fact that the site was a streamsink required a particularly cautious approach, due to the risk of solid and liquid contaminants disturbed during removal being washed deeper into the karst system. Also of concern was the stability of the steep marginal slopes of the depression containing the streamsink. Some of these slopes comprised clayey sediments resting on partially buried rubbish.

There was concern that ongoing fluvial erosion might cause slumping and collapse as the feature adjusts to a more stable state following removal of the anthropogenic fill. These issues were addressed by close supervision of the excavator, hand picking rubbish where possible, and follow-up erosion mitigation measures. Some rubbish buried in the walls of the depression was left in situ, to avoid seriously destabilising already over-steepened slopes. The condition of the site will be the subject of ongoing monitoring.

A bewildering array of rubbish was extracted from Elderberry Cave, in addition to the car bodies that initially attracted attention to the site. A lot of it was typical household rubbish, but of more concern was the considerable amount of agricultural refuse, including drums for petroleum products, veterinary products and chemicals, as well as barbed wire and other sharp rusty objects. A large quantity of broken asbestos sheeting was removed from the site by a qualified operator.

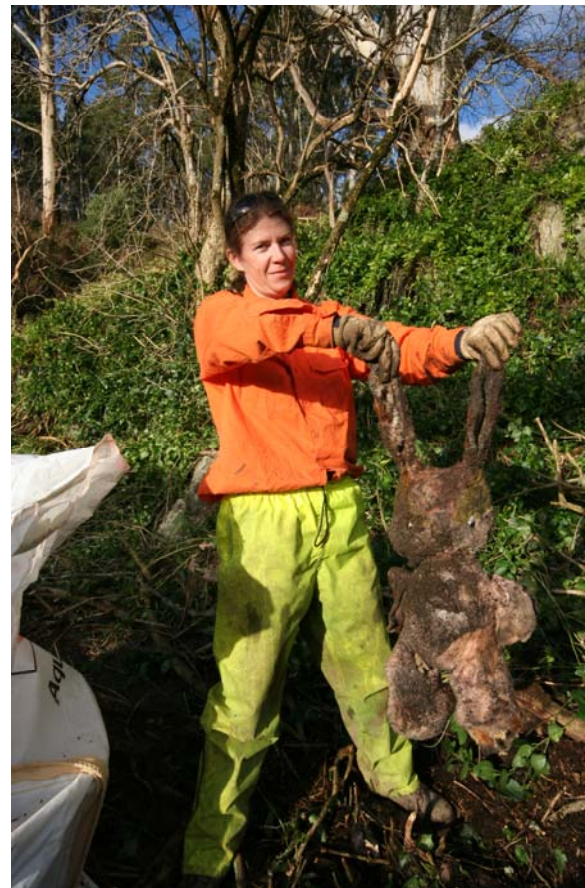
Linda and the giant pink bunny.

This work was supervised Linda Overend from PWS Mole Creek, supported by a team from Mole Creek and other PWS field centres. The PWS staff demonstrated a high level of commitment and professionalism under often arduous and unpleasant conditions. Not a nice job, but they stuck at it with good humour until it was done.

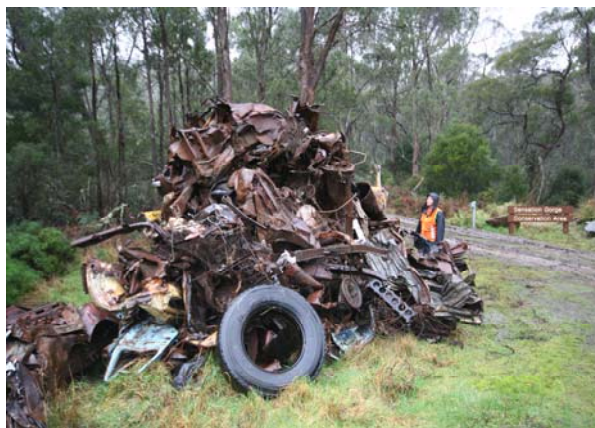
Stockpile of metal rubbish to be recycled
– Sensation Gorge Conservation Area

Car bodies, batteries, fridges, drums, machinery and building material including a large amount of asbestos were recovered from the Sensation Gorge Conservation Area. Thankfully, the considerable number of farm animal carcasses that had evidently been dumped there had been

largely consumed by native animals or rotted away. Seventy tyres were removed from one sinkhole alone. Material was winched out on cable or chain where the depth and steepness of the sinkholes precluded reaching it with a grabber or bucket mounted on the excavator arm. Smaller rubbish was bagged and carried out by hand.

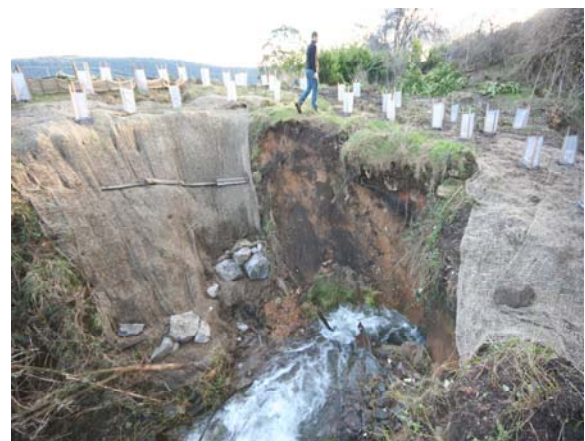
Elderberry Cave following rehabilitation.

The follow-up rehabilitation involved putting down jute matting on the steeper disturbed slopes and installing silt traps to reduced eroded sediment being washed into the streamsink from adjacent disturbed ground. A quantity of native seedlings was planted. Weed management will be an ongoing issue at this already badly weed infested site. The possible involvement of Karstcare volunteers in follow-up weed control activities has been discussed with Karstcare co-ordinator David Wools-Cobb.
