THE SAGA of the PINK TERRACES:

Rolan Eberhard

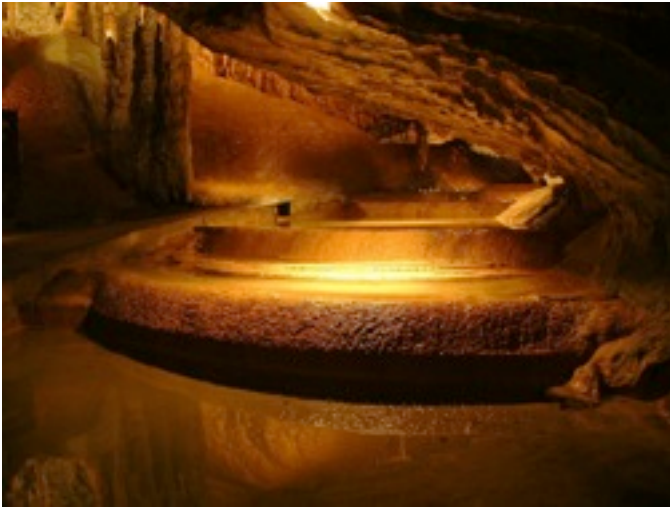
Plate 1: Rimstone barriers towards the upstream end of the Pink Terraces. The pathway on the side was established in the late 1930s; prior to this, parties may have walked directly on the flowstone or the rimstone barriers. Photo: Paul Flood

At some stage the rimstone barriers were modified by cutting notches into them, releasing impounded water

Close inspection of the Pink Terraces revealed that although parts of the rimstone barriers were composed of hard crystalline material, as would be expected of actively depositing features, other parts were quite porous and even pitted with fist-sized holes. It was tempting to jump to the conclusion that this was due to solutional attack by aggressive water. In fact it had to be acknowledged that there were other possible explanations, such as physical damage sustained during a century of activity by tourists and cave guides. More compelling evidence was required, as the arrangement

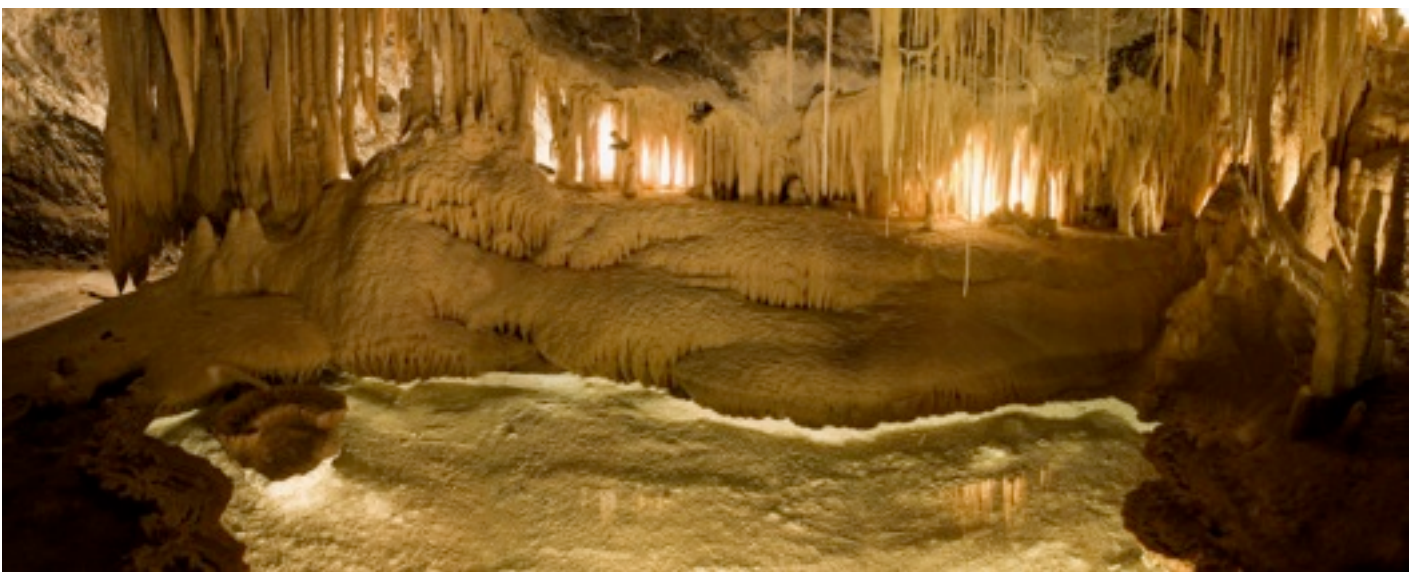
Plate 2: The Lily Pond – looking good following cleaning and restoration of the natural hydrology (cf. Plate 4). Photo: Paul Flood

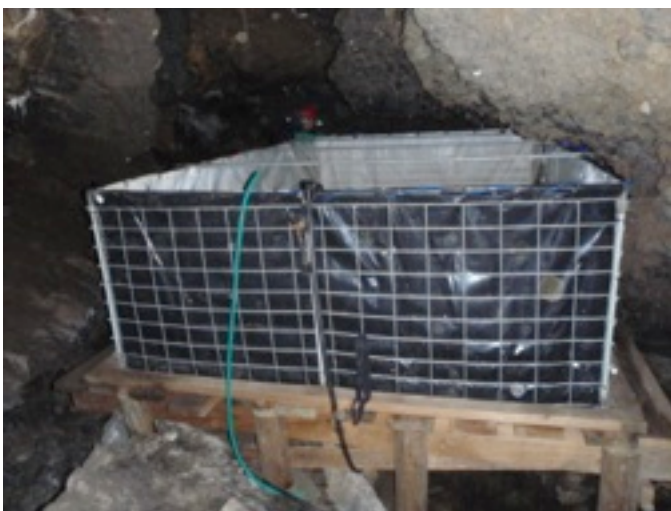
Plate 3: 16,000 litre holding tank in upper level of Short Creek passage.

Under natural conditions the source water at both sites is derived entirely from percolation flows (i.e. drip water). This could not be controlled; however, it could be supplemented by diverting water from other sources, such as perennial streams elsewhere in the same cave. This was deemed an appropriate thing to do. Accordingly, the following solution was engineered: (1) install inside the cave one 16,000 litre holding tank, comprising a plastic liner supported in a steel frame resting on a treated pine base, (2) pump water from creek into holding tank, regulated by a float valve at the tank, and (3) gravity feed water from the tank to the Pink Terraces and Lily Pond as required, controlled manually via a gate valve. These works were completed and the system operational sometime in the 1990s (Plate 3). The holding tank was located in an undeveloped section of the cave above Short Creek, the source of the water, and was not visible to those participating in tours.

Regarding the possibility of contamination due to leachate from the CCA-treated pine base of the tank, water samples were collected from a shallow pool of standing water beneath it. These were analysed for dissolved arsenic, chromium and copper – active

ingredients in CCA-treated pine (Table 2). All samples showed elevated results for these metals compared to other sites around Mole Creek, where earlier sampling had returned results mostly below detection limits (Eberhard & Houshold 2002). Leachate from the pine beams was clearly implicated.

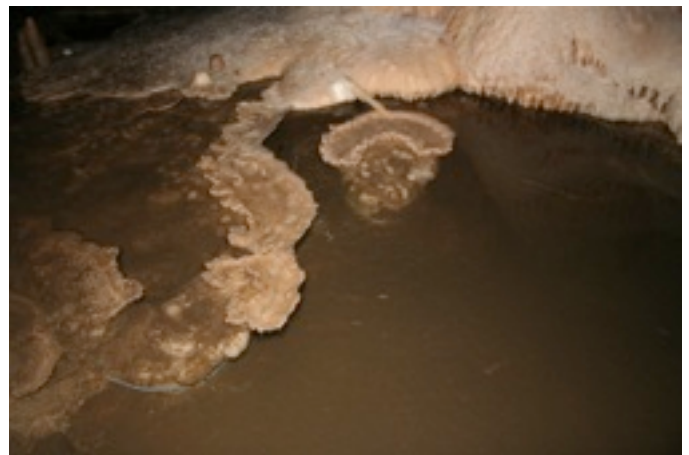
For a period the new arrangement appeared to be successful – that is, water levels in the ponds could be maintained during dry periods – but new problems became apparent. Short Creek originates from a surface stream rising high on the slopes of Western Bluff. It is derived mainly as runoff from non-carbonate rocks, has a flashy hydrological regime, and carries a variable load of organic material and sediment. It was found that water pumped into the holding tank contained suspended material that settled out in the tank, the Lily Pond and the Pink Terraces. Attempts were made to fix this by periodically vacuuming the base of the tank using a device for cleaning swimming pools. Despite this, sediment continued to accumulate, giving in the Lily Pond and the Pink Terraces a dull sludgy appearance (Plate 4).

Plate 4: The Lily Pond in April 2007. The dark material on the base of the pond is sediment from Short Creek (cf. Plate 2).

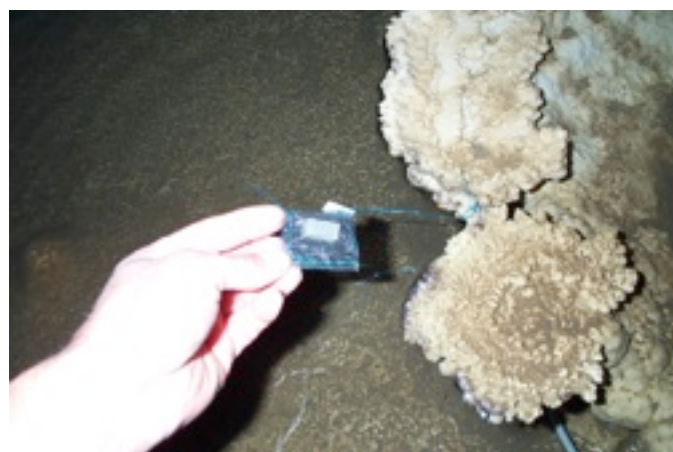
Cave manager Paul Flood had inherited the set up described above and was supportive of further investigations. Consideration was given to using chemical data to model the state of saturation of the water with regard to carbonate minerals. This was not pursued for a variety of reasons. Instead, an approach was adopted that harks back to 1970s' experiments to quantify rates of erosion in different environments, using standardised blocks of precisely-weighed limestone. At Marakoopa the principal question was whether speleothems in the ponds were being eroded or deposited – quantifying the rate at which this was occurring was not critical. For our experiment we used small pieces of crystalline calcite cut into rectangular tablets weighing 4-5 g each. These were ultrasonically cleaned, dried at low temperature and weighed to four decimal places. The tablets were then encased in plastic mesh envelopes and suspended in the ponds at the Pink Terraces, Lily Pond and a few other places in Marakoopa Cave (Plate 5).

Plate 5: Calcite tablet in mesh envelope.

The tablets were retrieved after 12 months, removed from the mesh envelopes, cleaned, dried and weighed. Results are presented at Table 1. A negative change in weight was interpreted as evidence of erosive reduction; a positive change was interpreted as evidence of depositional accretion. Strictly speaking, results cannot be compared quantitatively between tablets, as their dimensions, and hence surface areas available for erosion or accretion, were not strictly standardised. Even so, they can be considered as qualitatively indicative of the relative intensity of erosion or accretion at the different sites.

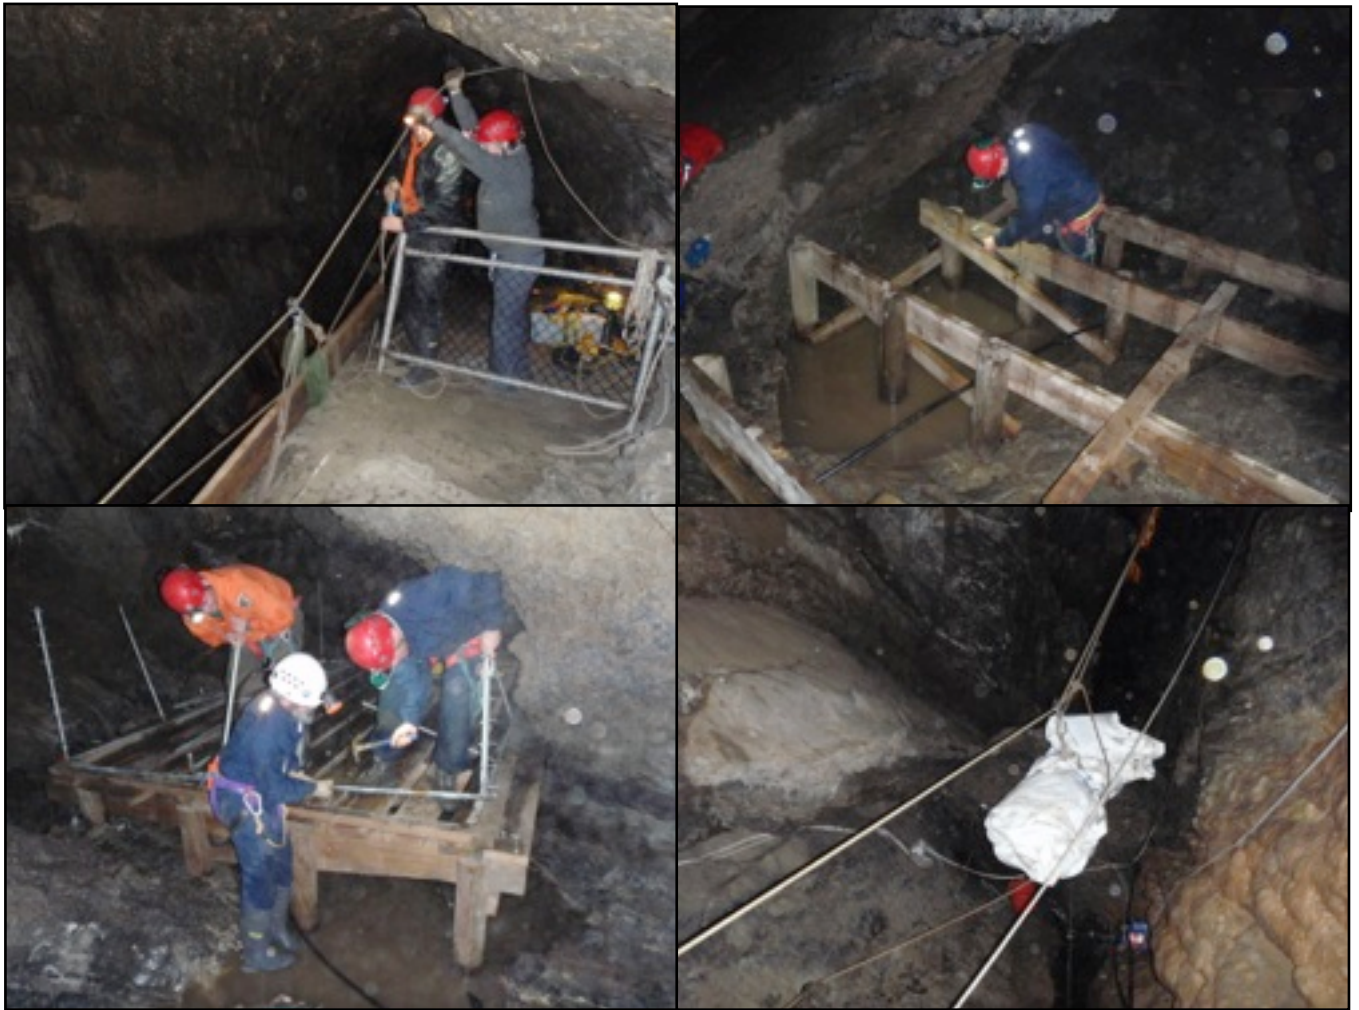
Plate 6: Dismantling and removing the holding tank, June 2010. Photos: Rolan Eberhard

The results of these investigations, and a recommendation that ‘the appropriate response is to cease diverting water into the [Pink Terraces and Lily Pond] and to remove the associated infrastructure’, provided the ammunition Paul Flood needed to obtain support for shutting down the diversion. Removing the tank itself was no trivial task, as the structure had first to be dismantled and then ferried piecemeal across a 10 m deep canyon above Short Creek. This task was coordinated by Parks and Reserves Manager Chris Emms and completed in July 2010 (Plate 6).
