EFFECT of an INTENSE RAINFALL EVENT JUNE 2016 on CAVES at MOLE CREEK, TASMANIA

Rolan Eberhard

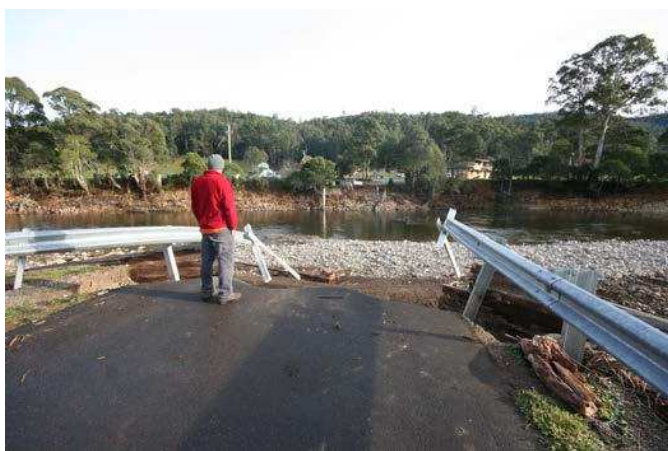
Liena Bridge on the Mersey River – destroyed during the flood

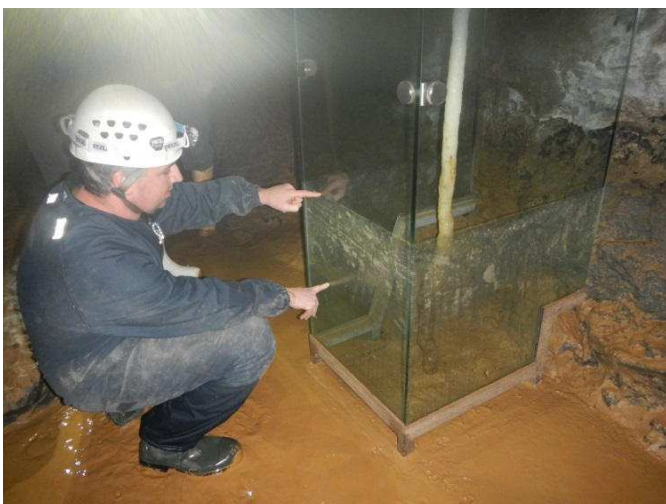
Cave guide Dave Lee at the Tuning Fork speleothem (The Railway Tunnel, Marakoopa Cave), indicating the level of the June 2016 flood versus a lesser flood in January 2011.

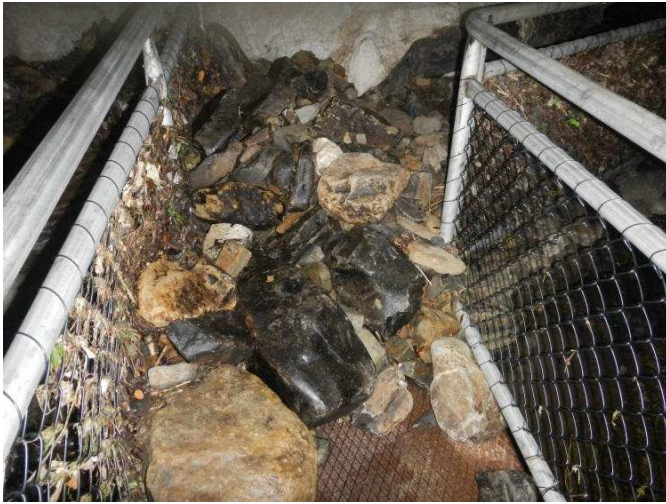
Bouldery debris deposited by floodwater on tourist path in Marakoopa Cave.

The effects of the flood were most severe on Long Creek, especially the downstream portion developed for cave tours. The following changes were observed: large volumes of gravelly sediment had been displaced, undermining concrete paths and viewing platforms or burying them to a depth of 0.5 m; sediment build-up had displaced the course of Long Creek, re-aligning it onto the tourist path for a distance of 15 m; relictual sediment banks up to 4 m high had been destabilised and in some cases collapsed onto pathways; boulders up to a metre in diameter had moved, impeding access through the cave; flowstone sheets deposited on gravelly fills had been undercut and some had fractured; lights and wiring had been torn away. Lesser effects were observed in the The Railway Tunnel – a fossil conduit used to provide access for tours to a viewing point on Short Creek. Water had evidently ponded up within this passage, bringing with it a flux of mucky silt. The net result of these various effects was not a pretty sight for a cave manager first thing on a Monday!

stream to back up, flooding Byards Chamber and contributing to the failure of a rock and mortar wall at the cave entrance. Second, a low reach of passage further upstream of the junction with The Railway Tunnel created a bottleneck which trapped gravels moving downstream during the flood. Whilst this section of passage had been artificially enlarged many years ago to increase headroom for tourists, it was also made more constricted at stream level when a path and safety barrier was installed. The resultant build-up of material was responsible for the aforementioned displacement of the watercourse onto the tourist path.

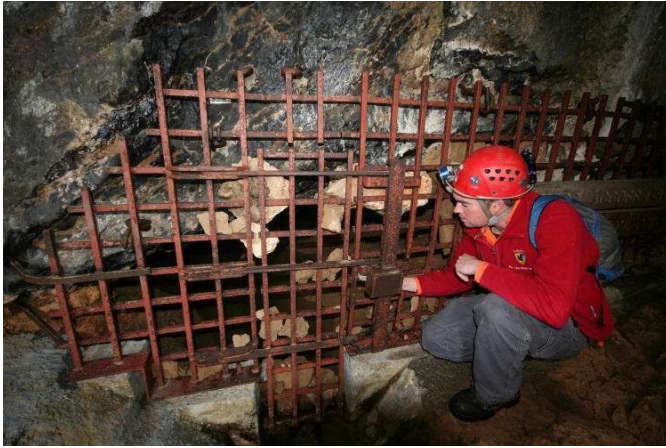
Ranger Dan Bowden inspecting the cave gate at Croesus Cave. Note boulders lifted by floodwater and pinned between the gate and cave entrance.

entrance and along the surface watercourse below it. The outward force of water on the cave gate – a seemingly robust structure of 20 x 20mm steel bar welded into a rectangular mesh anchored to a concrete base and ring bolts drilled into the rock – had been sufficient to bend the steel bars and deform the overall structure. Rocks weighing tens of kilograms were found suspended at various points around the margins of the gate on the inside, having been lifted by the force of water and wedged in gaps between the steel frame of the gate and the adjacent rock. Entry to the cave had to be delayed until assistance had arrived in the form of a team with cutting tools.
