## A trip into Inchindown Caverns, Scotland

### John Brush, Canberra Speleological Society Inc

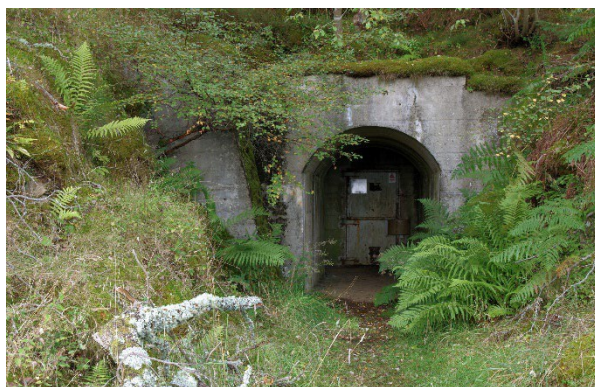
*Figure 2: Portal for the smaller access tunnel (right).*

On the day of the trip, we arranged an early breakfast at our hotel and made good time to the designated meeting point at a cafe just a couple of kilometres from the tanks. We then drove up into the forested hills. At the end of the road, all six of us (Preston, Kaye, Hazel, David and us) changed into Tyvek overalls, sorted out gumboots and adjusted helmets (*Figure 1*). I was asked if I could carry a bucket of sand, but the reason for this was not very forthcoming. We then walked a few hundred metres to a concrete tunnel portal nestled into the bush (*Figure 2*).

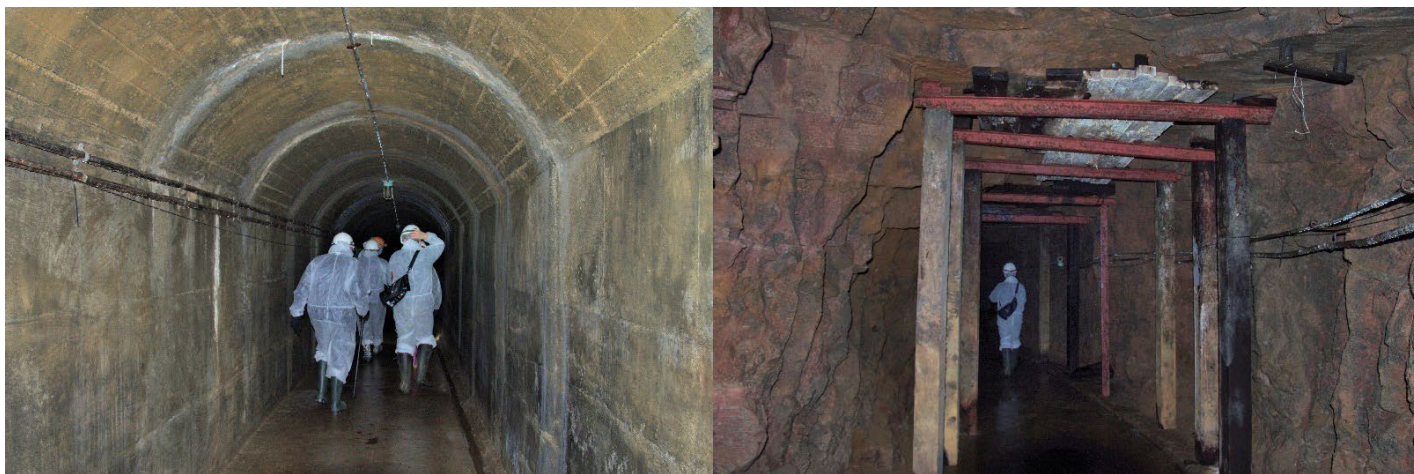
Figure 3: In the concrete-lined section of the small access tunnel (left)

Figure 4: Rock walls and wooden pit props in the more distant parts of the smaller access tunnel (right)

The access or service tunnel was about 1.5 m wide and 2 m high with vertical walls and an arched roof (Figure 3). It connected to one end of each of the oil storage tanks. It was concrete lined for the first couple of hundred metres, near where the first tank was located, but beyond that the tunnel was bare rock as excavated around 80 years ago. In the unlined section there were wooden pit props shoring up the roof in a couple of places where there appeared to be some roof instability (Figure 4).

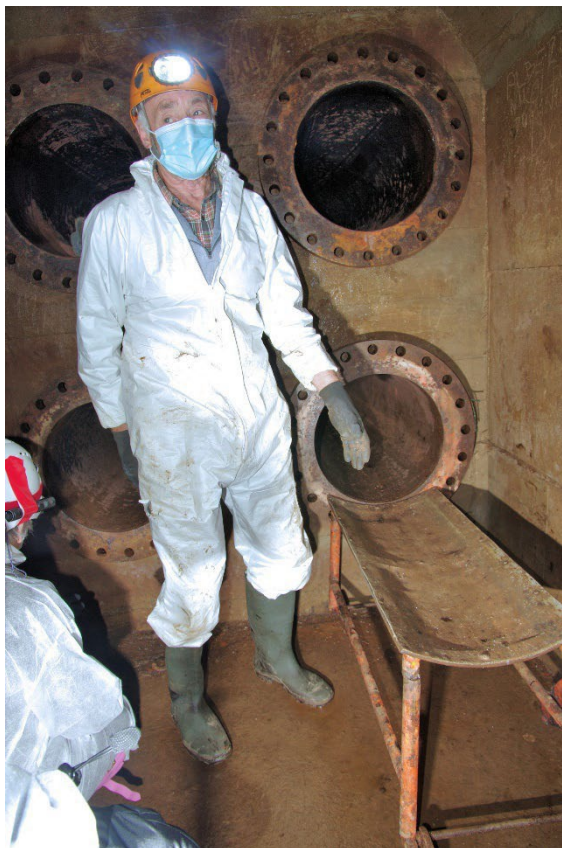
Figure 5: Preston with the custom-made bench at the access point to Tank 1 (left).

At the first passage junction, we turned into a short side passage. It ended at a concrete wall that had four protruding pipes, each about 50 cm in diameter. The original cover plates on the pipes had been removed so it was possible to peer a couple of metres through the pipe to see the interior of Tank 1. It was, we discovered, also the access point into the tank. All the other tanks had a similar setup. However, to make access into Tank 1 easier, one of the pipes had a concave-shaped bench attached to it (Figure 5) and there was a low-profile trolley matching the curvature of the bench that could be pushed into the pipe.

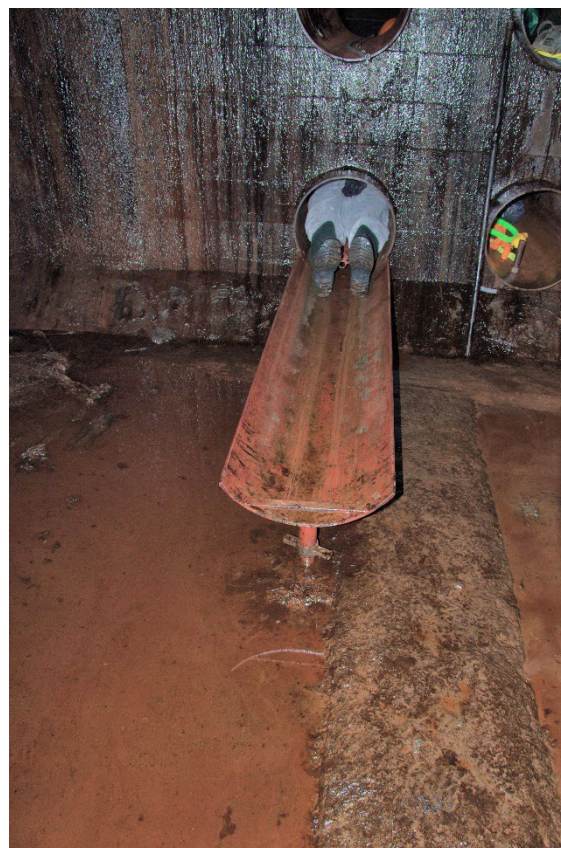
Figure 6: Emerging into Tank 1 on the low-profile trolley (right).

With the aid of a hook on the end of a long steel rod, the trolley was used to push everyone through the pipe to a matching bench inside the tank (Figure 6). Most of us had to lie face down on the trolley and fold in our shoulders to fit through.

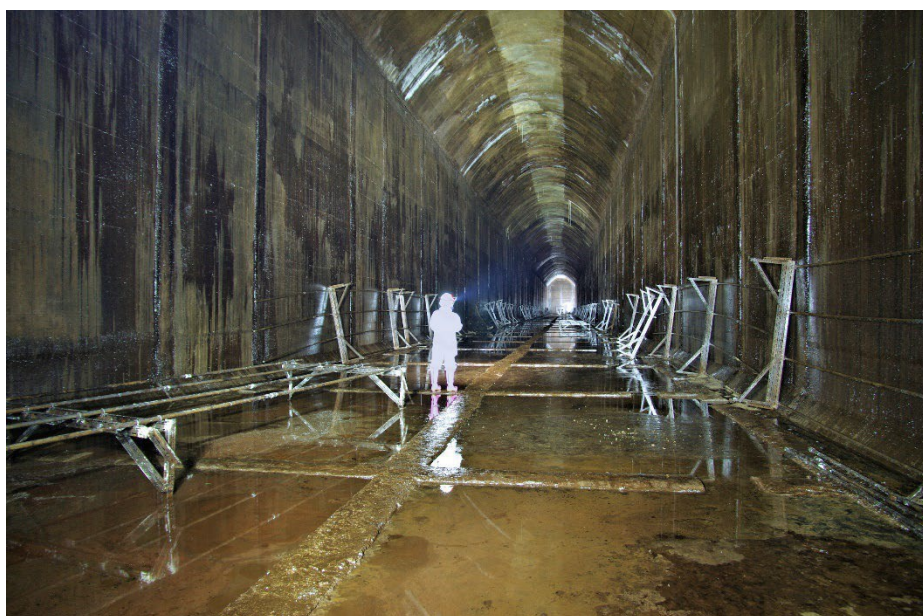
Figure 7: Interior of Tank 1, one of five identical tanks, each 237m long

Five of the storage tanks are of identical size; 237 m long, 9 m wide and 14 m high. They are lined with concrete 45cm thick, have a vaulted ceiling and are spaced 15 m apart. They originally had metal racking about half a metre above the floor to support heating pipes, but this has all been dismantled and is stacked along the walls (Figure 7). We were told this was to facilitate the cleaning work in 2006.

The floor has a central raised concrete ridge running the length of the tank and there were regularly spaced lateral ridges running out towards the side walls. Despite the cleaning, it is filthy inside the tanks. The walls were streaked with a thick, black, tarry layer. And there was a layer of oily mud on the floor. It seems oil is continuing to seep out of the concrete walls. Surprisingly, there was only a faint smell of oil.

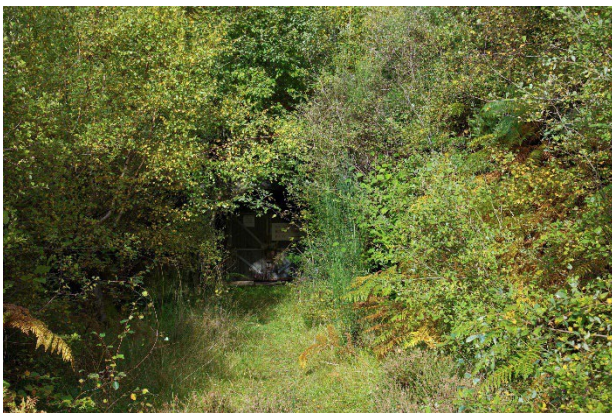
Figure 8: Portal for the main access tunnel (below)

After we returned to the surface, we walked to the portal of the second and larger access tunnel (Figure 8). Here there were also signs of forced entry and in fact, some of Preston's hidden security features had been damaged, most likely by a thin cutting disc attached to a portable angle grinder. We spent some time making rudimentary repairs and discussing how to make the gate more resistant to any future angle grinder attacks.

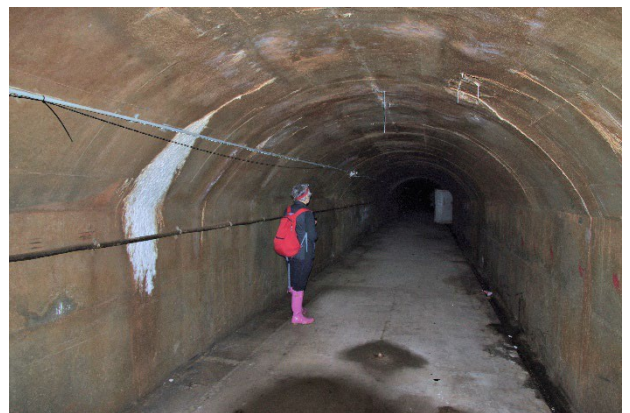
Figure 9: Typical view along the main access tunnel (right)

The main access tunnel (Figure 9) is about 2.5 m wide and has large oil pipes embedded in the concrete floor. All the valves to control the flow of oil were operated manually, as was the winching arrangement for raising and lowering the fuel supply pipes inside the tanks, as noted above (Figure 10).
