'GONE BUT NOT FORGOTTEN'

Caves of the Cobden Quarry, West Coast, South Island, New Zealand

Mary Trayes

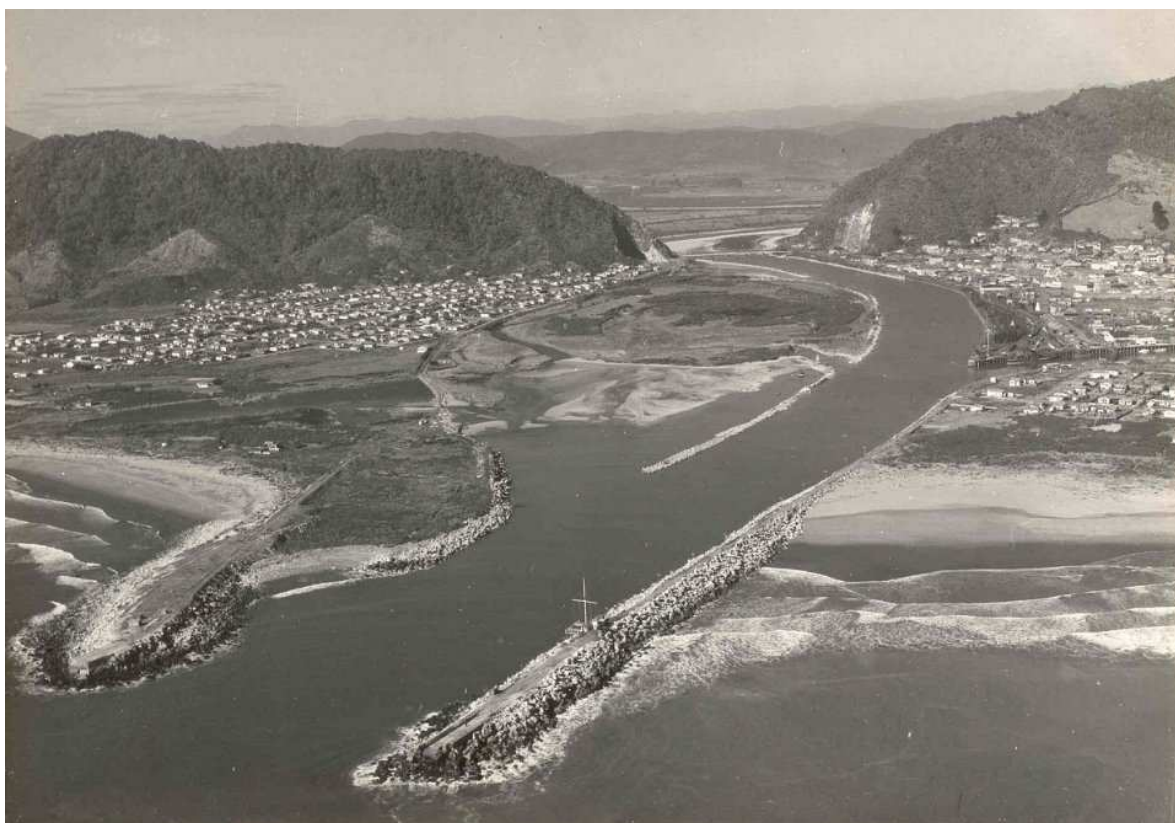
Figure 1: This 1950's White's Aviation photograph shows the north and south breakwaters, and a half tide wall along the Grey River. The Greymouth Gorge is in the back-ground with the obvious 'hole in the hill' on the left (north side) being the Cobden Quarry. Photo: History House Museum, Greymouth

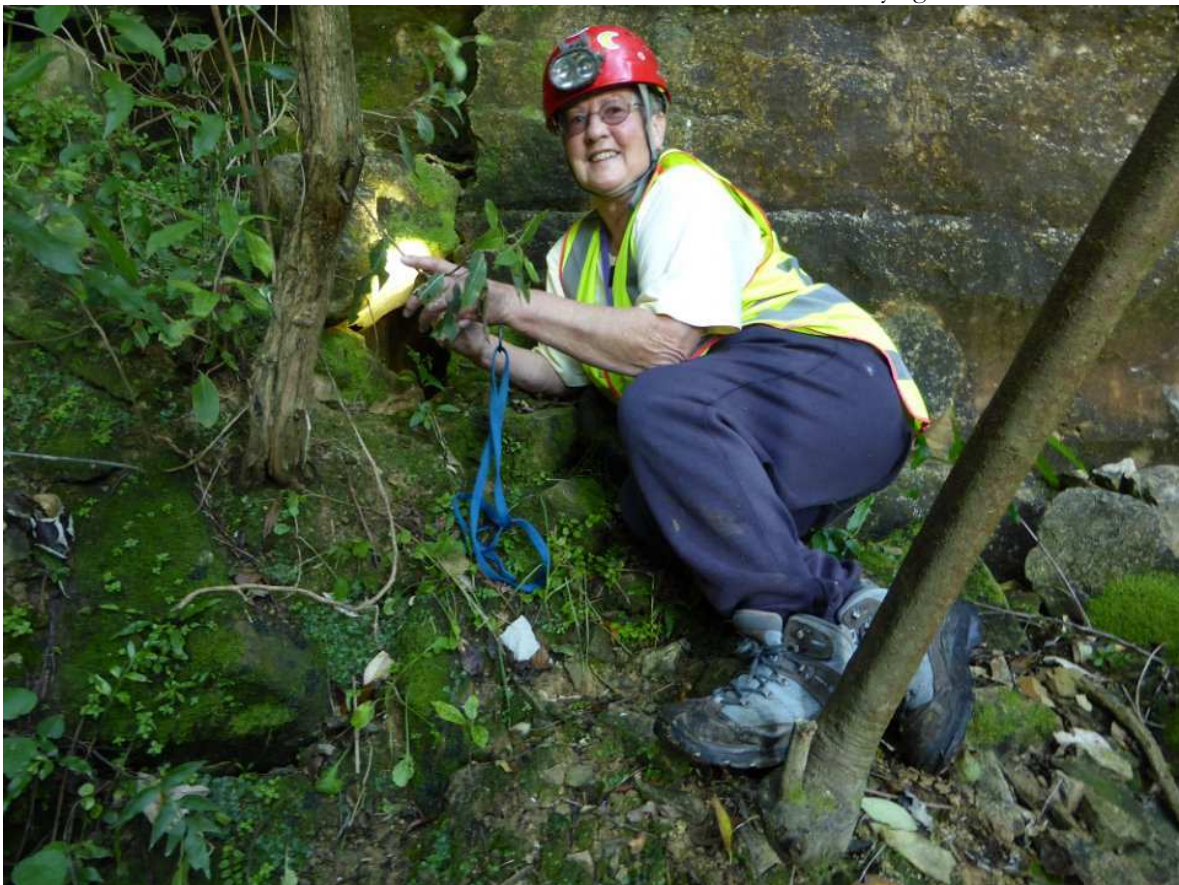
Figure 3: The author at the former entrance to the cave uncovered by blasting in 1999. Despite the entrance now being covered by a large rock, vestiges of the cave were still visible on this visit in February 2014. Photo: Bruce Annabell

When the cave was uncovered those present soon realised that the blast had de-stabilised the cave roof, making it unsafe. So after retrieving some accessible formations, another blast was made which dropped a large rock down over the entrance of the cave, effectively sealing it. When the author and a friend went looking for the cave in February 2014, they found it still sealed although it was possible to look down a number of holes into the cave with the aid of a torch. There were also small mossy stalactites around the former entrance and pieces of broken formation lying about.

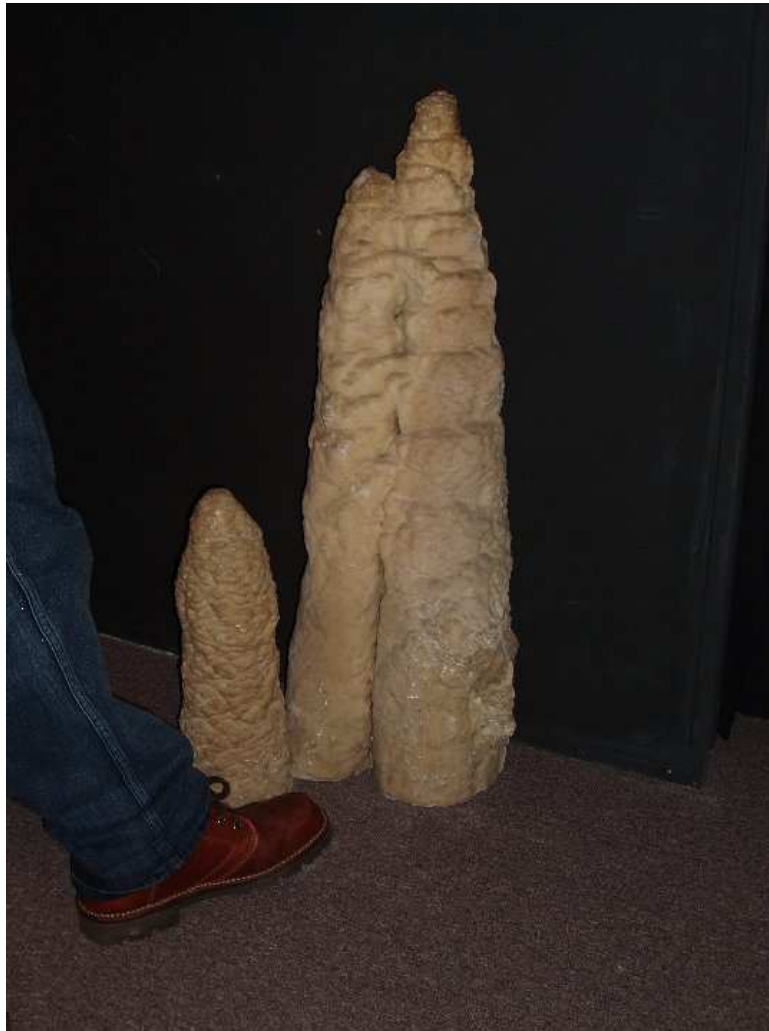
Figure 4: Stalagmites at the West Coast Gem & Mineral Club which were taken from the cave uncovered by blasting in 1999. The smaller one on the left has been sent to Melbourne University for dating. Photo: Mary Traves, 2013

In mid-2014 Graeme Warriner and the Gem & Mineral Club agreed that the smaller stalagmite (30cms high and 9.8 kg in weight) could be sent to Melbourne University for dating and in return she donated the stalactite she'd found to the Shantytown display. In November the stalagmite was sent over to Professor Russell Drysdale at the Geography

Department, Melbourne University and in May 2015 it was cut, and part polished ready for dating by mass spectrometry. The results of this are still pending as of July 2015 but Professor Drysdale said in mid-May that the polished surface *"looked interesting and showed plenty of visible changes that look suspiciously like millennial-scale climate events of the last glacial period."*

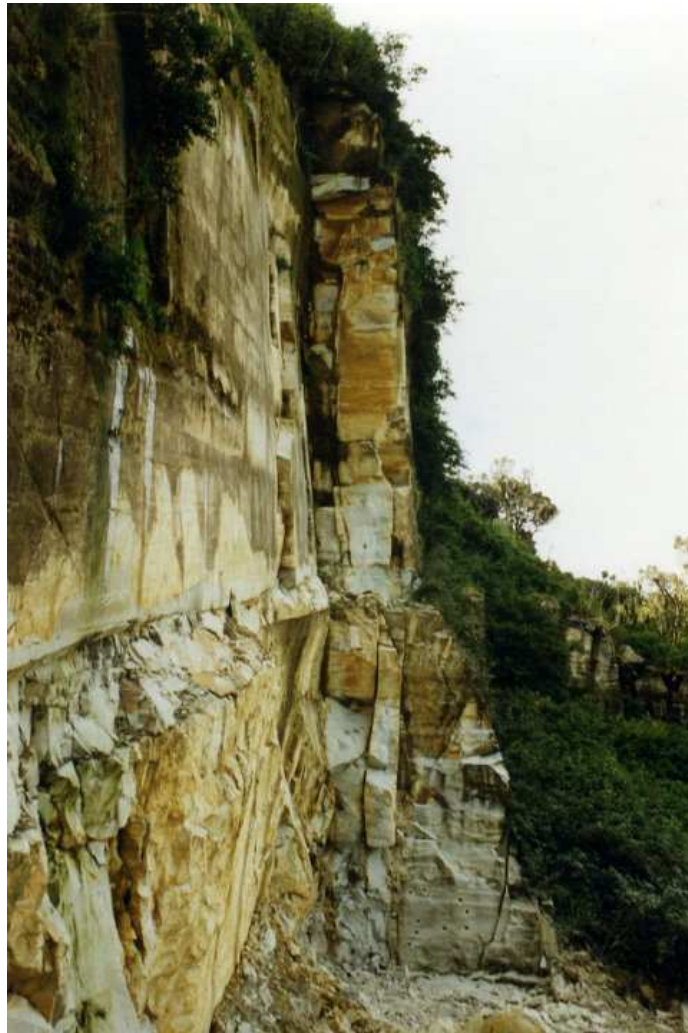
Figure 5: View along the quarry face looking east taken in the 1990's at the time of drilling for a small blast. Note the mudstone band at the point of the slight bulge in the quarry face. Photo: Graham Warriner

The presence of the wet clay, the main breakdown product of the thin mudstone bands in the limestone, may have exacerbated the rockfall rather than being the main cause. Photographs taken along the face in 1985 and again in the 1990's (see Figure 5) show a tendency for the quarry face to bulge out along the bands of mudstone. Perhaps this also occurred in 1902 before the face gave way.

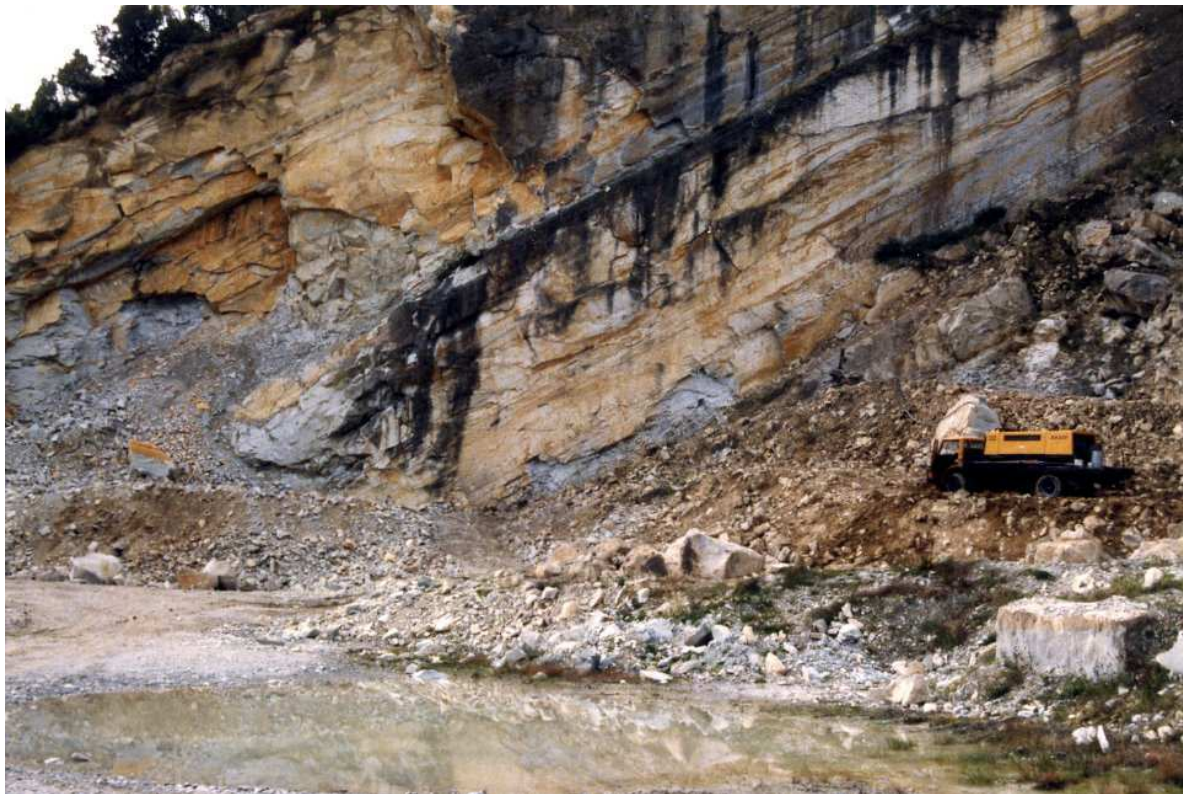
Figure 6: Preparatory drilling being carried out in the mid-quarry area in 1986. The drilling rig is near the face on the upper bench with a compressed air line running up to it from the compressor truck. Note the unstable area with overhang and arch, the result of blasting in November 1984. Photo: WCRC Collection

The potential for major rockfall was always there however and as late as 1986 a Quarry Inspector was expressing concerns about the stability of the western (lower) end of the main face after blasting in November 1984 left an arch of overhanging rock (see Figure 6). Not long after a cave was found to the right (east) of this and all care had to be taken when a blast was planned near it.

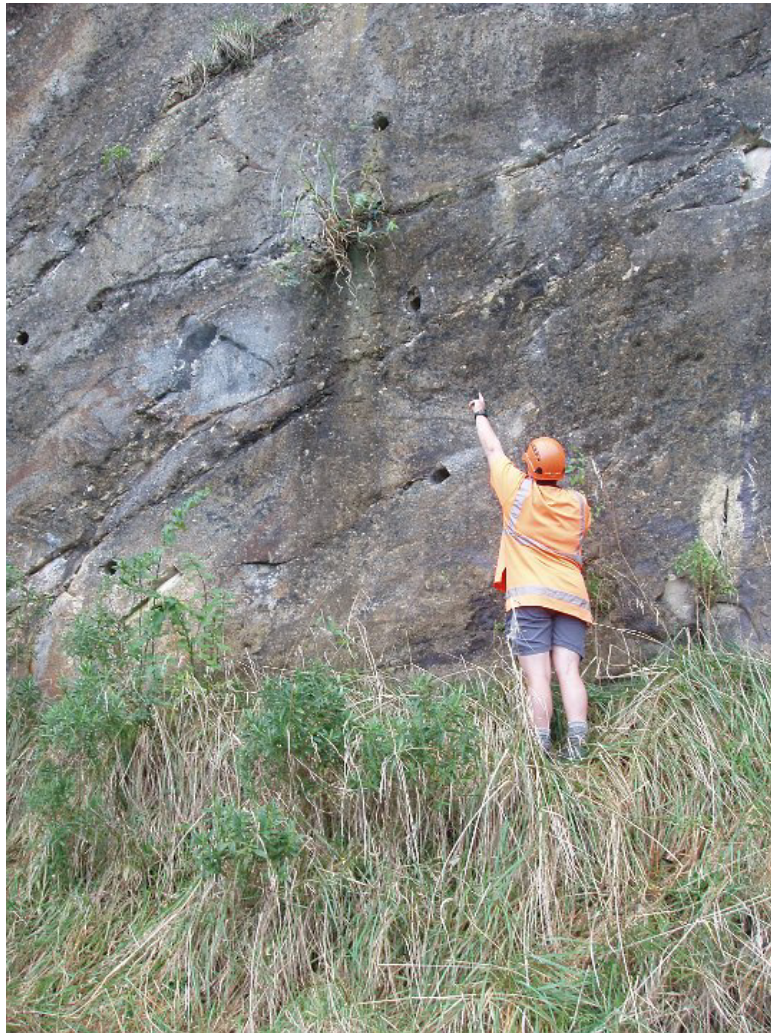
Figure 7: Karen Rohloff points to the water stain below one of the exploratory holes drilled into the western end of the quarry face around 2000. The water stain is an indicator that there is space – a cave- behind this end of the quarry wall. Photo: Mary Traves, 2013

In the early 2000's proof came that there was 'more cave' behind the quarry wall when several exploratory drill holes made into the western or lower end of the main quarry face went back into 'space' after only a couple of metres. It had been decided to explore rock reserves in this area because quarrying had actually gone outside the quarry boundary at the other, eastern end of the face (where the 1999 cave was found). However the lower or western end is also the one closest to Kells Hotel and some of the houses in Bright Street, and knowing that any blasting could be compromised by the presence of caves, with possible damage to the properties, it was decided to scale quarry operations down. After some minor blasting in the mid-face area in 2002 and then utilising what rock remained on the quarry floor, the Regional Council decided at their January 2005 meeting that they would close the quarry and rehabilitate the site.

In May 2013 the author and two friends checked out the exploratory drill holes made just a few years before. They shone high powered torches into a number of those within reach, but found their lights just disappeared into darkness after about 3m, noting also that a couple of holes near the ground had built up minor calcite deposits. The best confirmation that there was a space behind the wall actually came from two holes well up out of reach. This showed that water flowed out from time to time, water which could only have come from a cave.

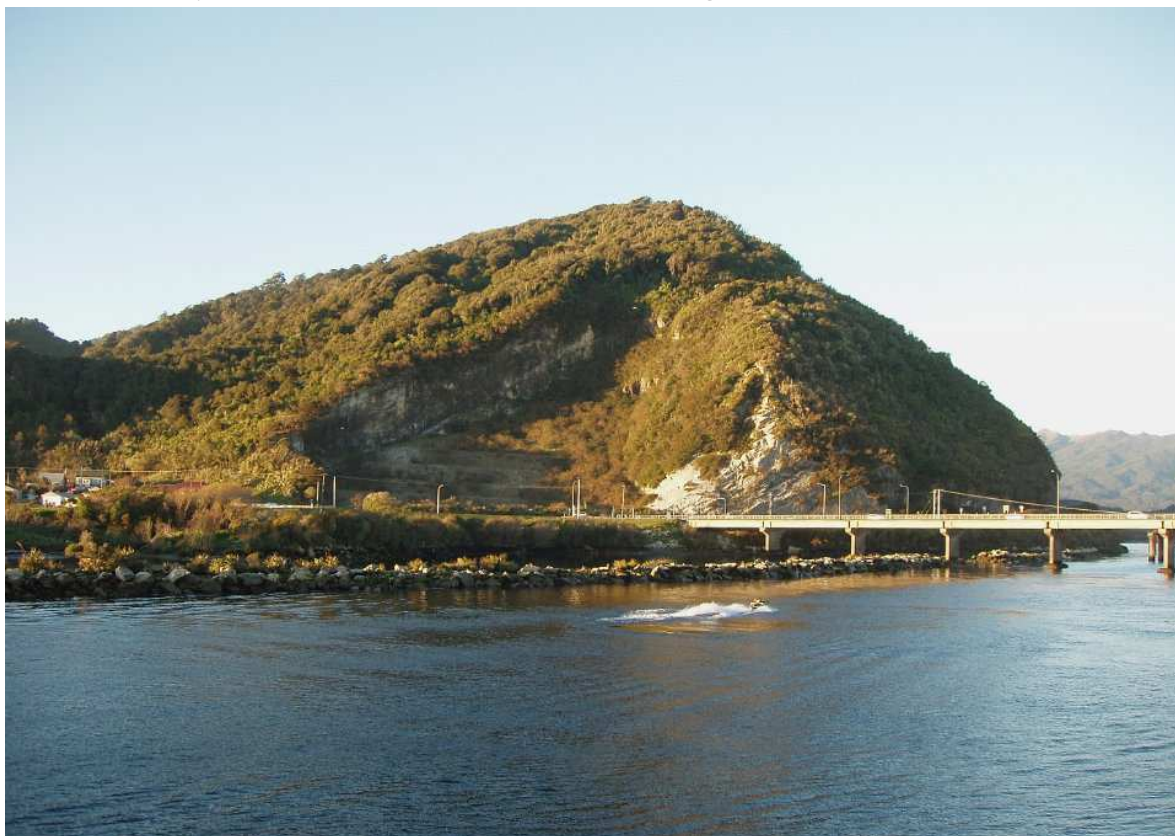
Figure 8: A late afternoon view of the former quarry in 2014. The lower terraces were planted as part of the rehabilitation work but the upper terraces have revegetated naturally. The photograph was taken from the Greymouth Floodwall and looks across the half tide training wall with the new Cobden Bridge at right and the red roof of Kells Hotel at left. Photo: Mary Trays
