A-tents at risk

Management of small-scale landform features, Cooleman Plains, Kosciuszko National Park

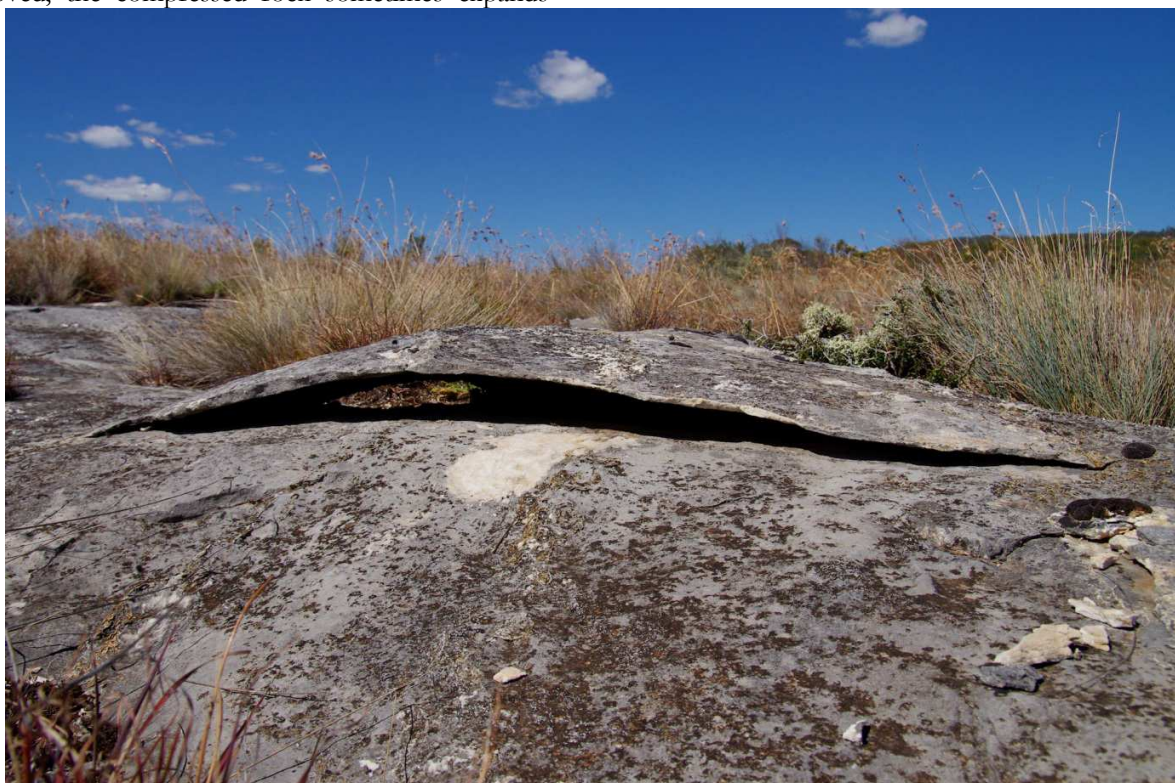
Figure 1 A perfect Cooleman Plains A-tent. Photo: John Brush.

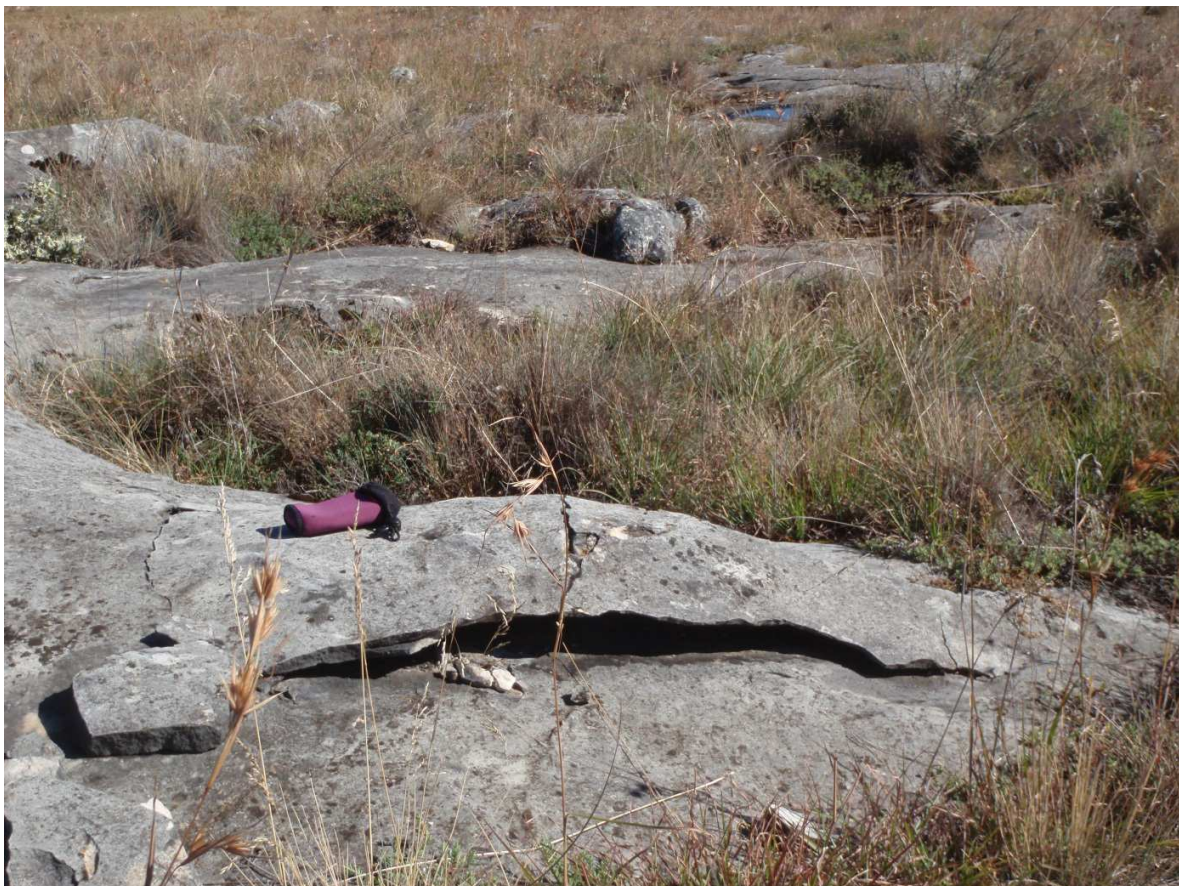
Figure 2 A-tent from Cooleman Plains. Note the lack of a joint at the right-hand end. Photo: Regina Roach.

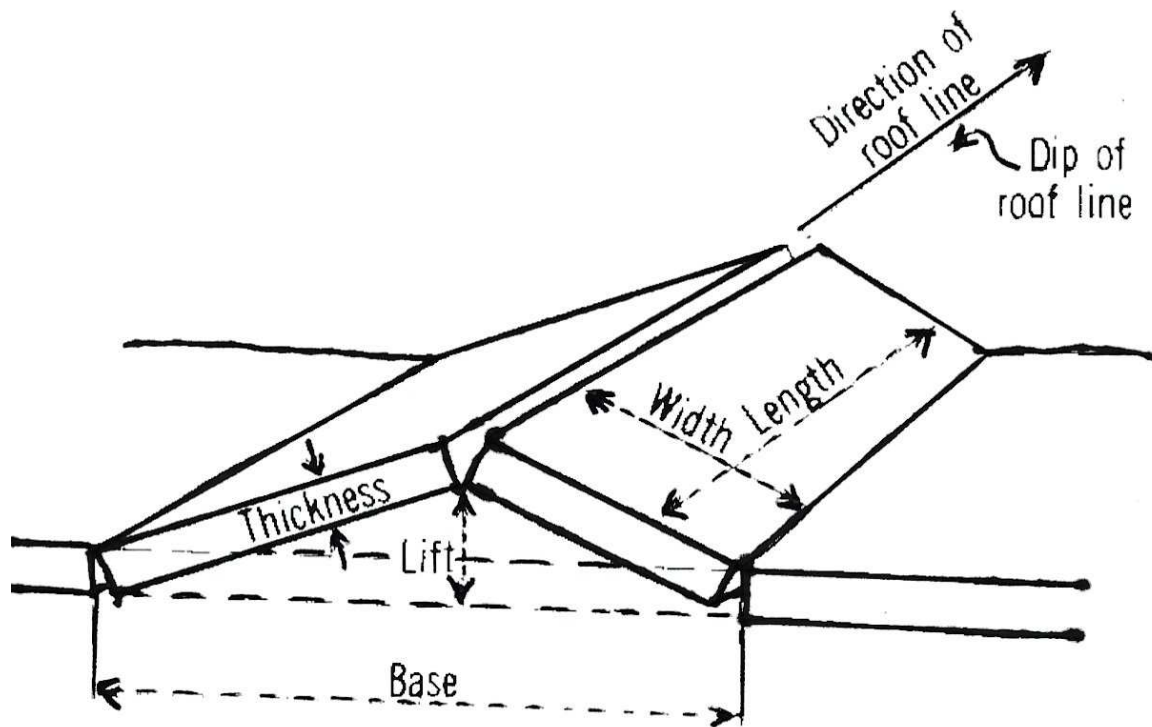
Figure 3 Schematic A-tent. Redrawn by Kirsty Dixon from Jennings and Twidale (1971).

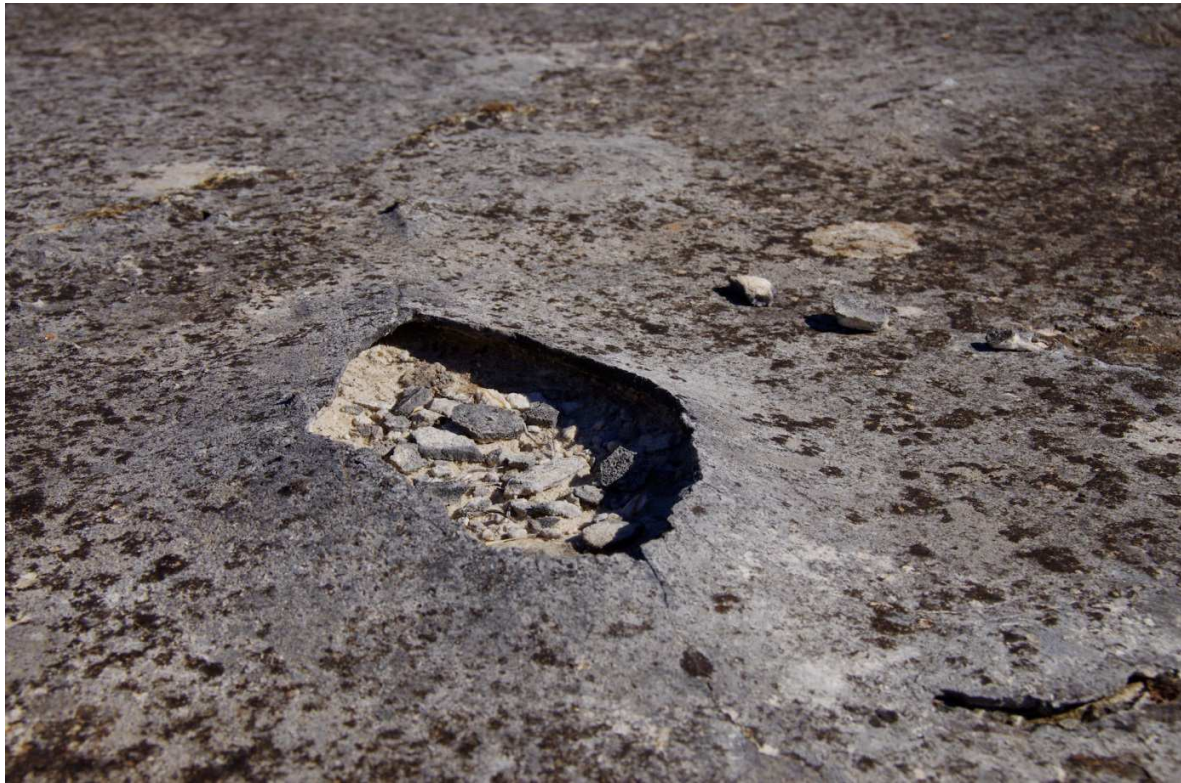
Figure 4 A collapsed Coolleman Plains blister. Photo: John Brush.

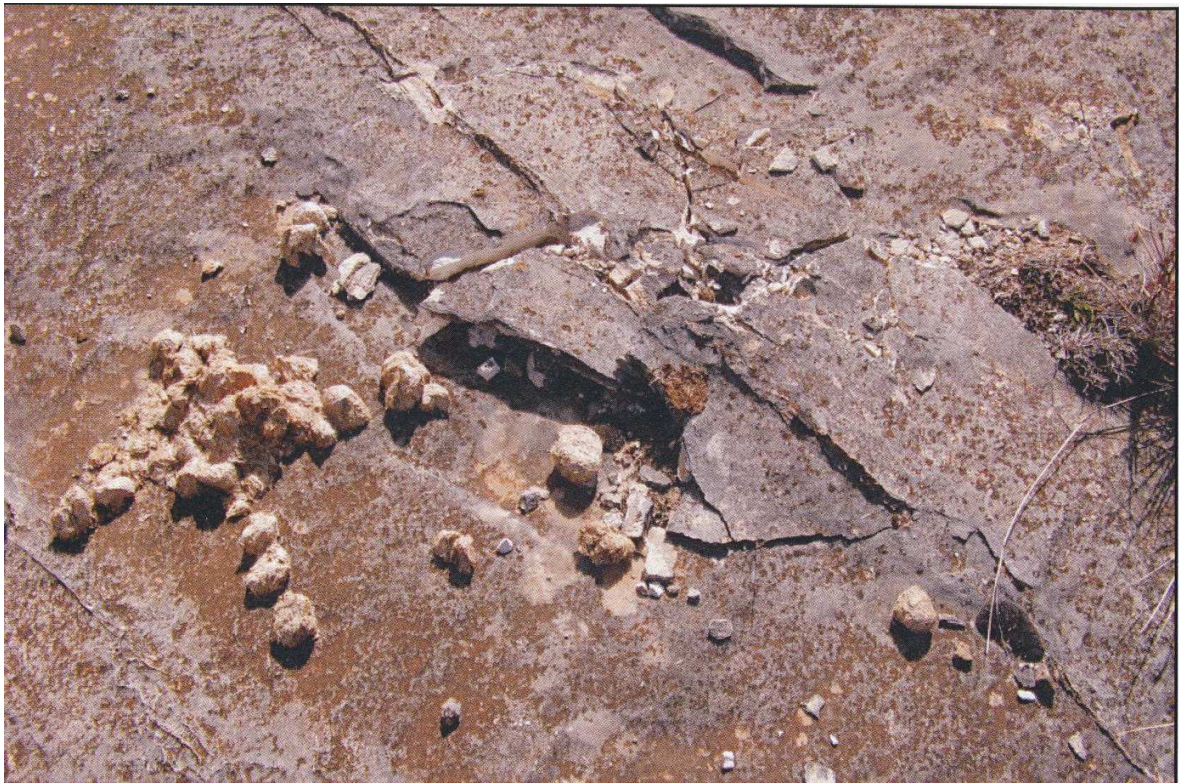
Figure 9 Horse-damaged A-tent. Source: Kosciuszko National Park Geodiversity Action Plan 2012-2017, Office of Environment and Heritage, NSW, unpublished.

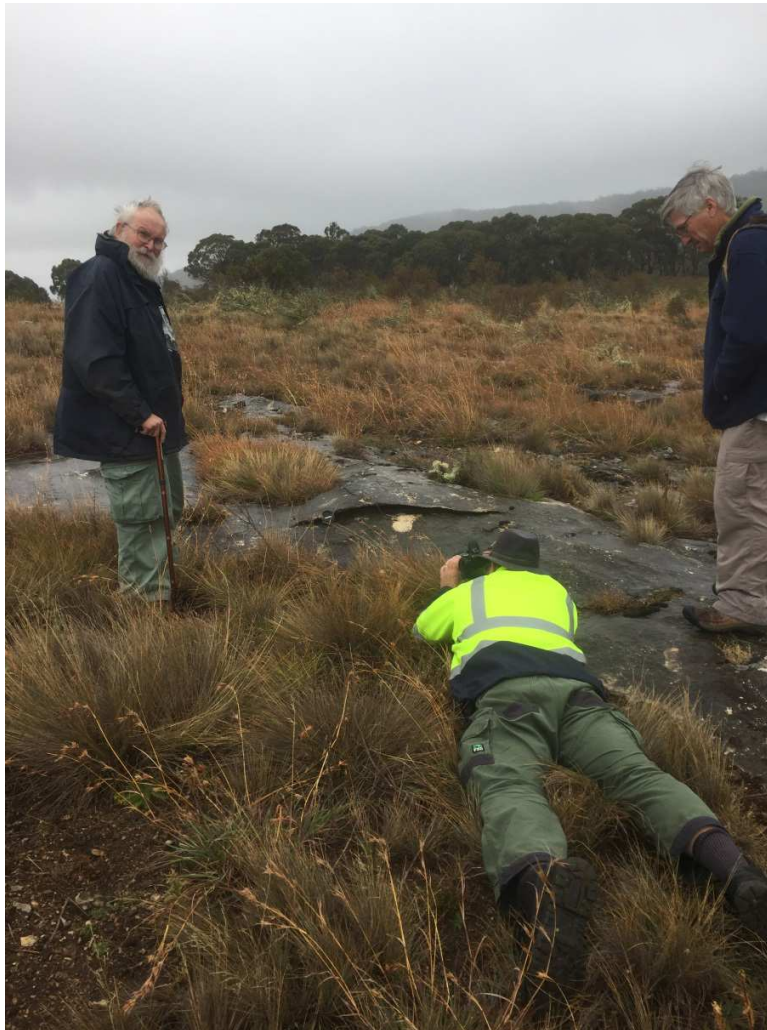
Figure 10 Note the lengths that NPWS staff will go to on a rainy day to get A-tent images. Photo: Steve Cathcart.
