UPGRADE TO POWER SUPPLY AT CAREYS CAVE

Geoff Kell

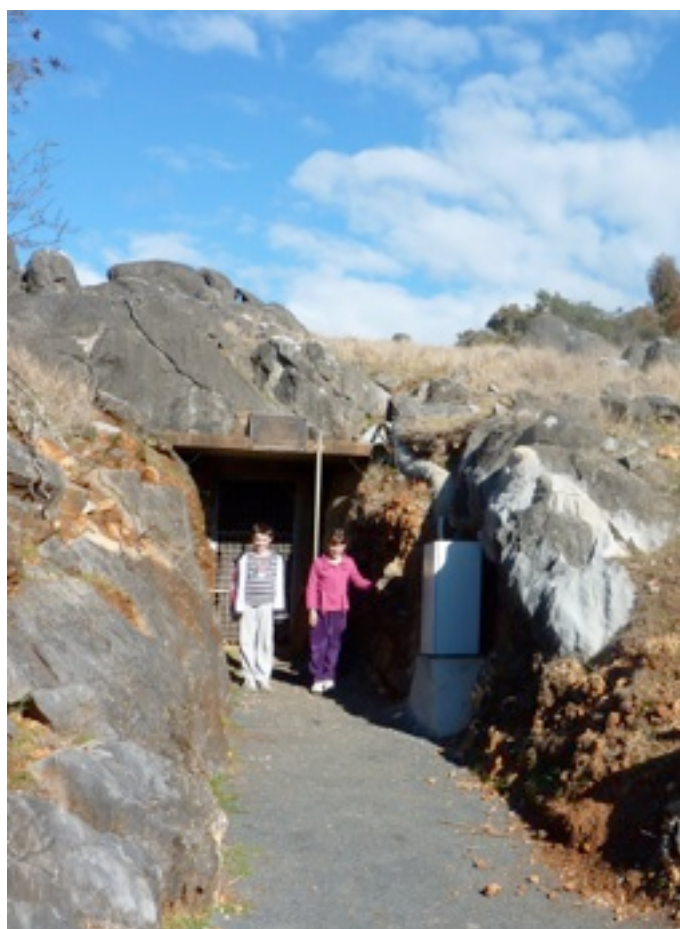
The final solution was to relocate a new mains pole down on the flat near the western site boundary and run the 240v feed underground to the cave entrance with a distribution board located in a new box at ground level (also housing a new 240v – 110v 5kva transformer). At the beginning of the epic I had pointed out to the power authority that we had been quite happy with the previous arrangement, they were the ones who wanted to change things, so in the end they agreed to supply both the new transformer and the cable and conduit to make all connections, including to the kiosk, if the Department of Lands undertook the installation. This has been duly done, the only problem being the ongoing inclement weather making for a somewhat mucky process and the trenches, while backfilled, have not been finished off so it will likely remain a construction site till summer.

Left. New power box at Careys Cave entrance.

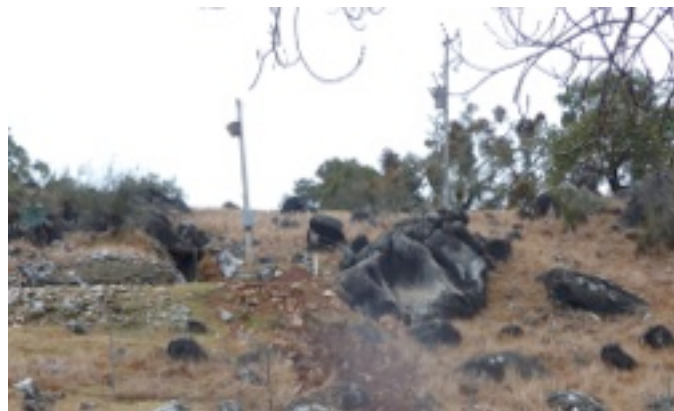
Careys Cave was originally developed in 1968 and underground regulations at the time required 110v supply in the cave. The power was grid fed with the mains pole located on the hill above the cave with a feed to a 110v transformer located on a sub pole near the entrance.

A few years ago a bloke from the supply authority came around banging ID numbers on poles – he put one on the sub pole (thereby claiming it as property of the power company). A while later another bloke came around drilling test holes in the poles and condemned the sub pole. As the power company now owned the pole it fell to them to rectify this situation: due to the rocky terrain above the cave it was not going to be easy access for machinery and they decided it was better to replace the mains pole as well while they were at it,

Right. Power pole prior to the new work
